INVESTIGATION OF SEVERE LIGHTNING STRIKE
INCIDENTS TO TWO USAF F-106A AIRCRAFT

J. Anderson Plumer

LIGHTNING TECHNOLOGIES, INC.
Pittsfield, Massachusetts 01201

Contract NAS1-15884
September 1981

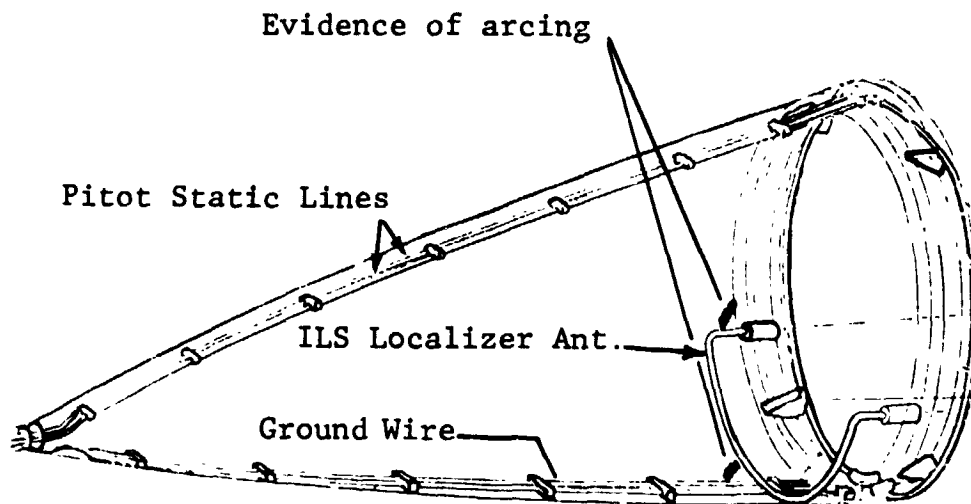
6. There was evidence of arcing between the ground wire and the ILS localizer antenna tube near the aft-most clamp, and from the localizer tube to the aft ring (across a 2.54 cm air gap). The locations of this arcing are shown in Figure 4.

Figure 4 - Locations of Electrical Arcing between the Ground Wire and the Localizer Antenna on Aircraft A.

4. After the aft ground-wire termination failed, the remaining lightning current arced over to the ILS antenna tube and from there to the rim, as was illustrated in Figure 4 and evidenced by melted spots at these places.
