SPECIAL INVESTIGATION REPORT

WING FAILURE OF BOEING 747-131
NEAR MADRID, SPAIN
MAY 9, 1976

AAR-78-12
c. 3

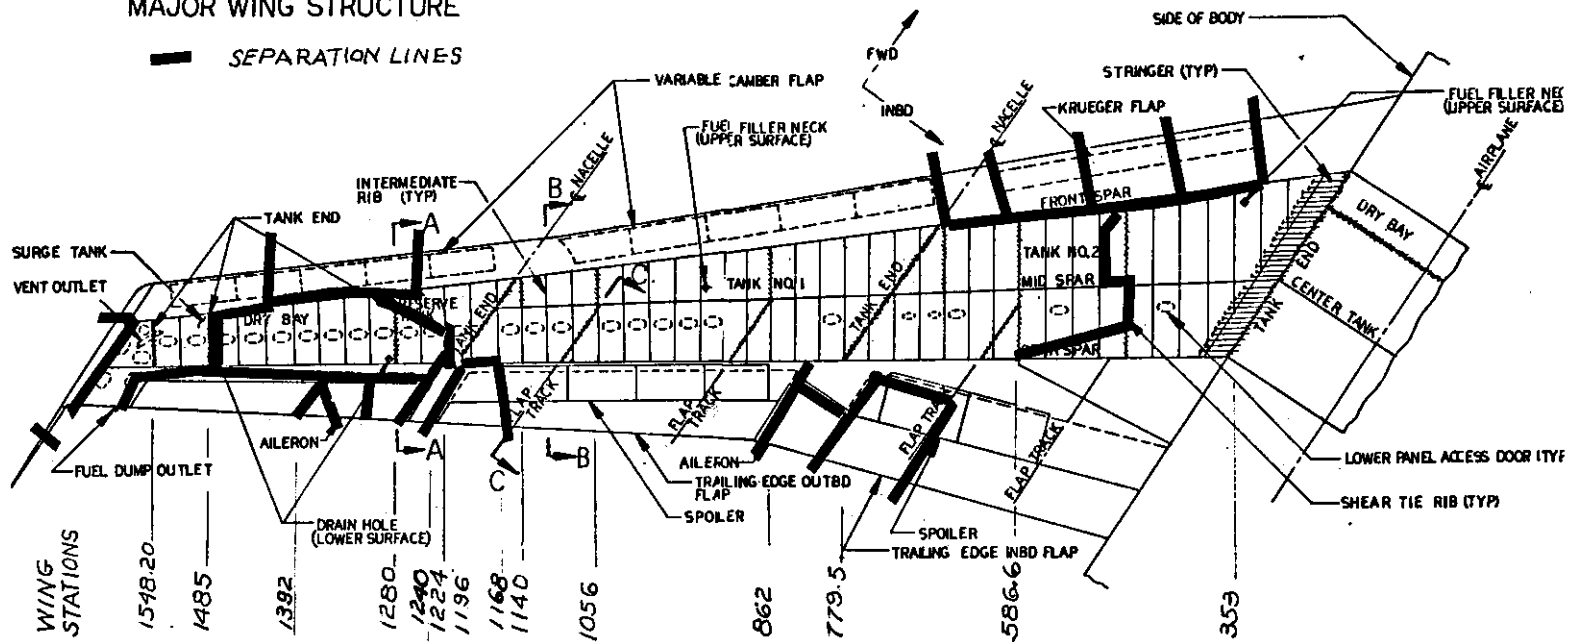
MAJOR WING STRUCTURE

Pitting and localized burn areas typical of lightning attachment damage were found on the left wingtip and on the vertical fin at the VOR antenna. The left wing had separated into 15 major pieces before ground impact and parts of it were found at each location of wreckage. (See drawing on page 31.)

— SEPARATION LINES
