INVESTIGATION OF SEVERE LIGHTNING STRIKE
INCIDENTS TO TWO USAF F-106A AIRCRAFT

J. Anderson Plumer

LIGHTNING TECHNOLOGIES, INC.
Pittsfield, Massachusetts 01201

Contract NAS1-15884
September 1981

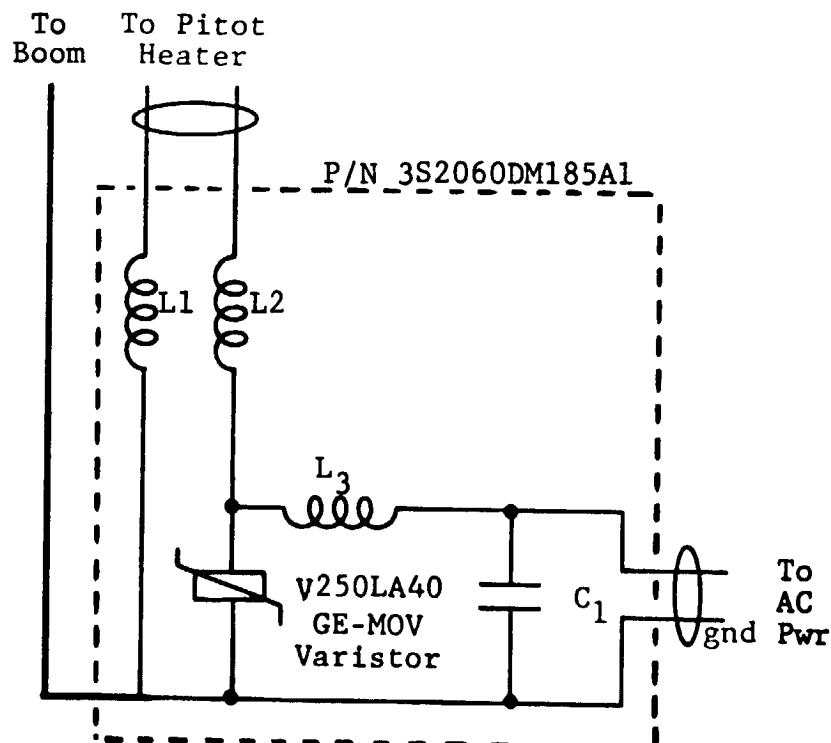
Figure 11 - Basic Electric Circuit of P/N 3S2060DM185A1 Suppressor.

The lightning suppressor incorporates a pair of series inductors, L1 and L2, to limit the amount of lightning current that can flow in the heater power harness to safe levels and force most of it to remain in the ground wire. A varistor and single inductor, L3, prevent damaging voltage surges from passing on into the aircraft. The suppressor circuit is shown on Figure 11.
