SPECIAL INVESTIGATION REPORT

WING FAILURE OF BOEING 747-131
NEAR MADRID, SPAIN
MAY 9, 1976

AAR-78-12
c. 3

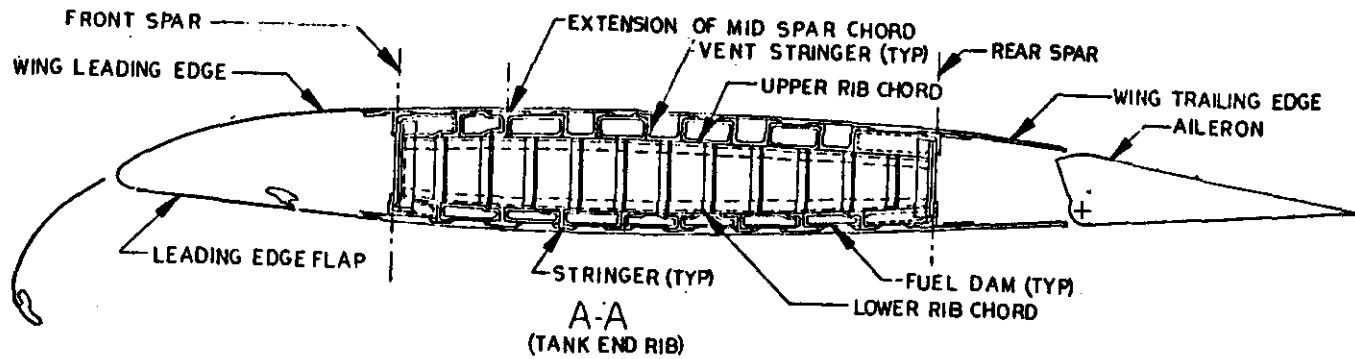
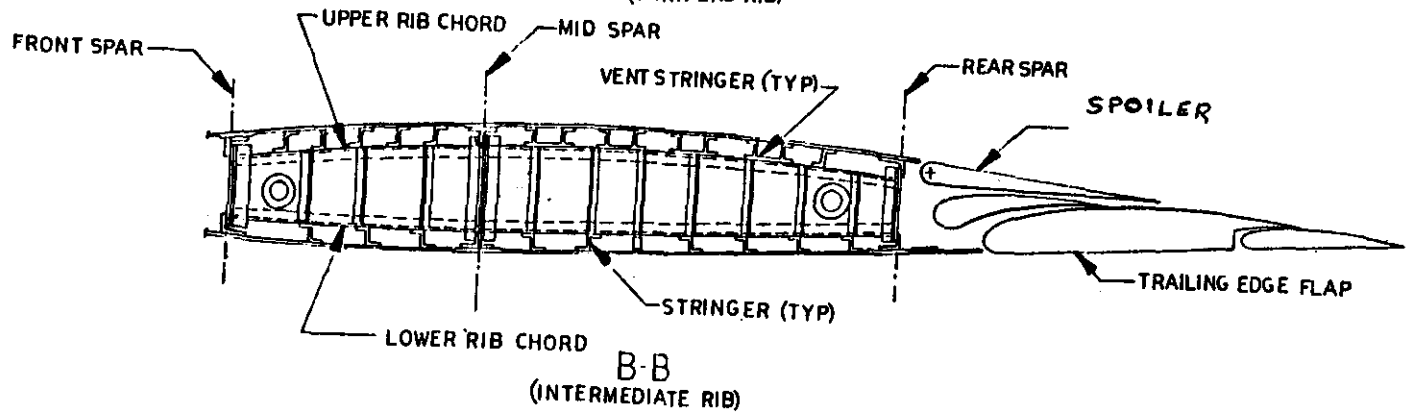
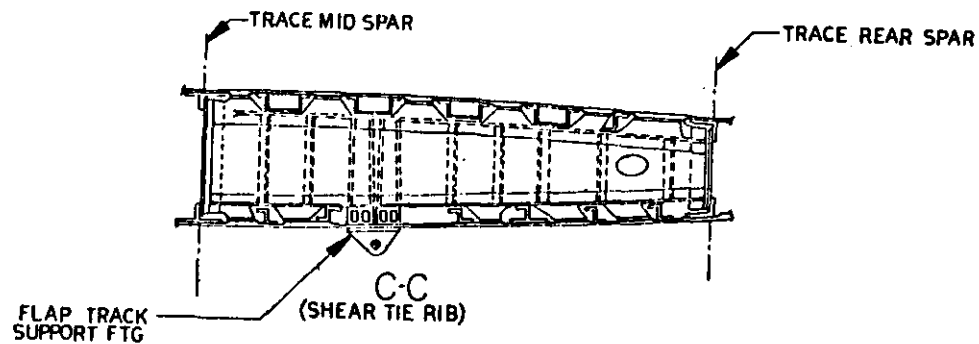
— SEPARATION LINES

Pitting and localized burn areas typical of lightning attachment damage were found on the left wingtip and on the vertical fin at the VOR antenna. The left wing had separated into 15 major pieces before ground impact and parts of it were found at each location of wreckage. (See drawing on page 31.)
