A Crewman's History of the McDonnell...

F-15 EAGLE

**Volume II
(Technical)**

(REPRINTS FROM MCAIR PRODUCT SUPPORT DIGEST)

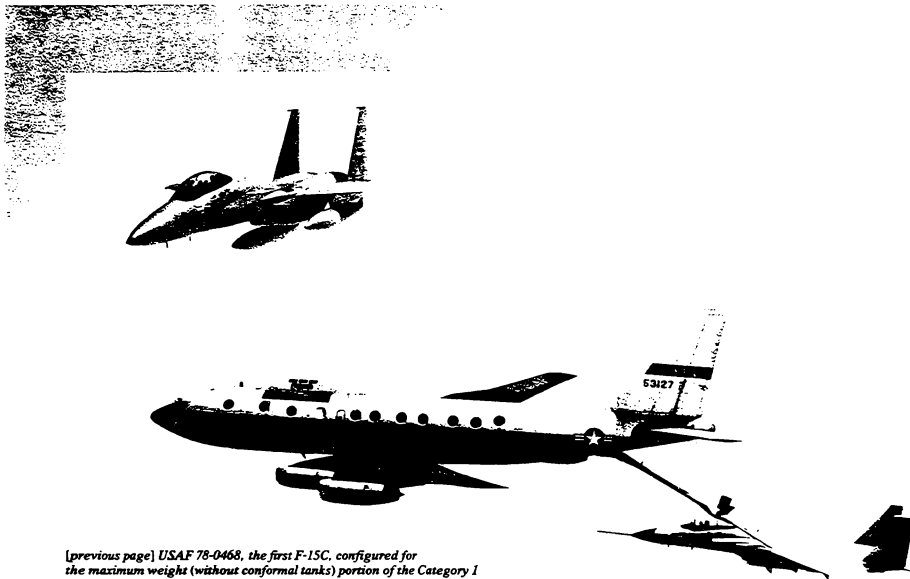
[previous page] USAF 78-0468, the first F-15C, configured for the maximum weight (without conformal tanks) portion of the Category 1 test program. [above] "C-1" conducted inflight refueling to test the fuel system operation (transfer rates, fill-up times, sequencing, etc.) and to "top off the tanks" prior to commencing the fuel transfer vs high fuel flow rate test. [inset] F-15B 71-291, shown during its 1974 unrefueled, nonstop flight from Loring AFB, Maine to Benwaters AB, England. In this configuration, F-15C/Ds would show 35,300 pounds on the gage!

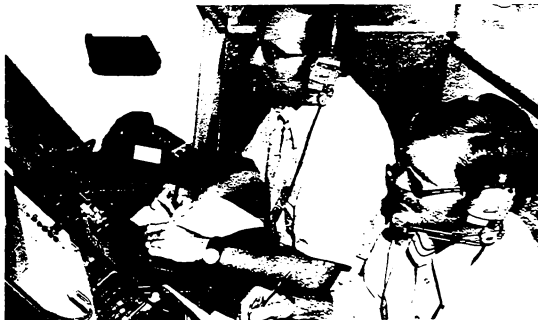
McDonnell Douglas flight test engineers Gary Trippensee (left) and Don Warren at the test director's position in the ground telemetry monitor station. All stations in the control room were linked via hot-mike intercom.

Tests were monitored by an engineering team that included a test director, aerodynamics engineer, flight test engineer, data engineer, and instrumentation engineer. Other engineering personnel were present as required for special tests, including propulsion and flight control system tests. The following displays were available to the test team in the mission control rooms:

- Four 6-channel strip chart recorders.
- Bargraph display of all PCM parameters.
- X-Y plotter displaying longitudinal vs lateral control stick position.
- Status light panel displaying information regarding control augmentation, instrumentation, and emergency power systems.
- Aural/light alarm system monitoring aircraft and engine over-temperature circuits.
- Dual video display providing a visual presentation of aircraft motions and a simultaneous display of aircraft geographical position and altitude on an adjacent screen. Aircraft motion display, with telemetry voice dubbed in, was recorded on a portable video tape recorder for playback in the post-flight debriefings.

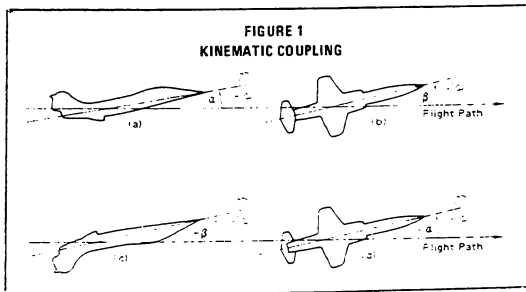
Kinematic coupling, as shown in Figure 1, is the simplest contributor to roll coupling.

As the airplane is rolled about its longitudinal axis from an initial positive angle of attack (α), the AOA is transformed into sideslip (β) after a quarter roll. As the roll continues, the sideslip is transformed into negative AOA at the inverted position, then into negative sideslip at the three-quarter point, and finally back to positive AOA after 360 degrees of rotation. As the roll continues, sideslip and AOA vary periodically with roll angle. This kinematic effect assumes that the airplane rolls around its longitudinal axis and neglects pitch and yaw stability moments which try to align the airplane with its flight path.

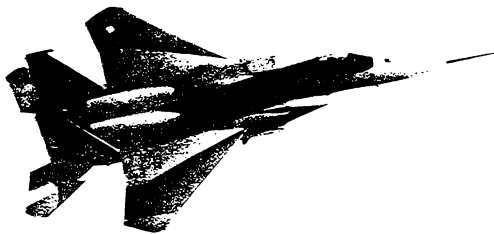
F-15 71-283 was used for Category I Load Tests at Edwards AFB. This was Eagle #4, and the first with raked wing tips. Painted black lines on wing and vertical fin were photographed from camera mounted in aft cockpit. From this film, wing and fin deflection could be measured.

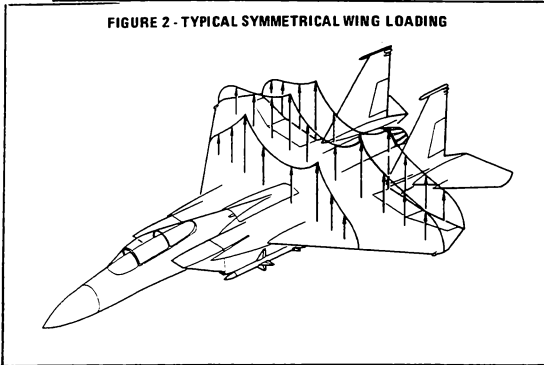
FIGURE 2 - TYPICAL SYMMETRICAL WING LOADING

- Symmetrical: Those flight conditions which load the airframe up due to angle of attack (AOA) only. That is, no lateral stick or roll is involved. A typical aircraft wing loading for symmetrical maneuvers is shown in Figure 2.

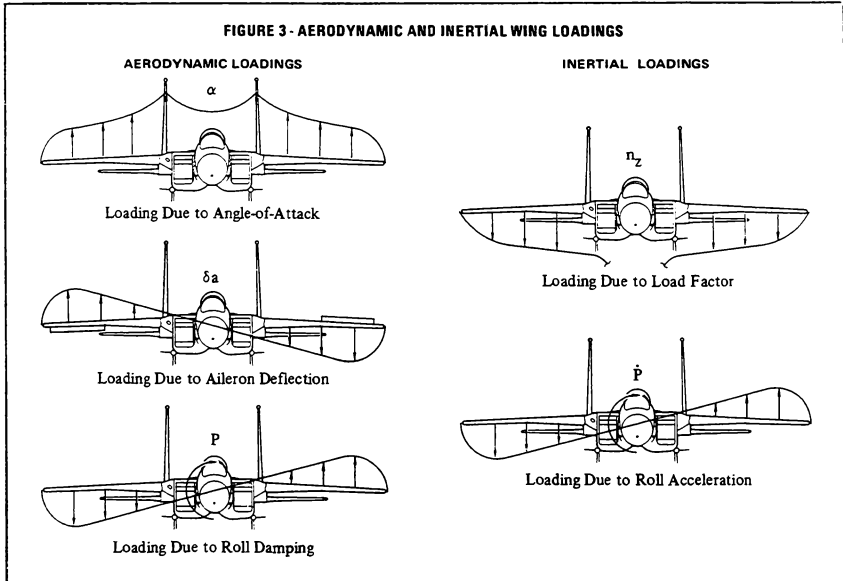
FIGURE 3 - AERODYNAMIC AND INERTIAL WING LOADINGS

sideslip maneuvers. When roll is introduced into the maneuvers, the wing loading is a combination of loadings from angle of attack, aileron deflection, roll damping, roll acceleration, and inertial loads from load factor. All of these various loadings are shown in Figure 3.

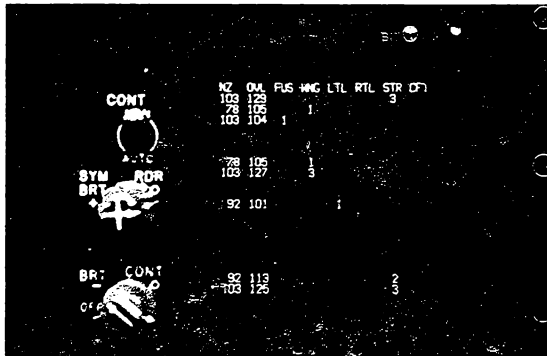
Laboratory test simulation of OWS digital display system on ANMI. Although data can be called up by pilot, primary use of cockpit instrument is to inform maintenance personnel what to inspect and to what degree components have been overloaded in flight. Data comes from Central Computer. First column shows load factors (N2) associated with percentages of overload (OVI) in second column. (Decimal points are omitted in first column — 103 indicates 10.3 load factor.) Remaining six columns are the components monitored by OWS — fuselage, wing, left tail, right tail, external stores, and conformal tank. Single digit numerical values are approximations of degree of component overloads — numeral 1 indicates overload between 100 and 109%; 2 is between 110 and 119%, etc. Incidentally, we sincerely hope the Eagle pilot never sees overload numbers as high as our laboratory simulation indicates: the overload warning tone/voice system would have alerted him long before numbers like these would show up!

been overloaded. These parameters can also be called up by the pilot and displayed on the Air Navigation Multiple Indicator (ANMI). A sample display can be seen in the photo below. This information will be used to determine what to inspect and to what degree, thus greatly reducing the manhours to inspect the aircraft after an overload condition has occurred.

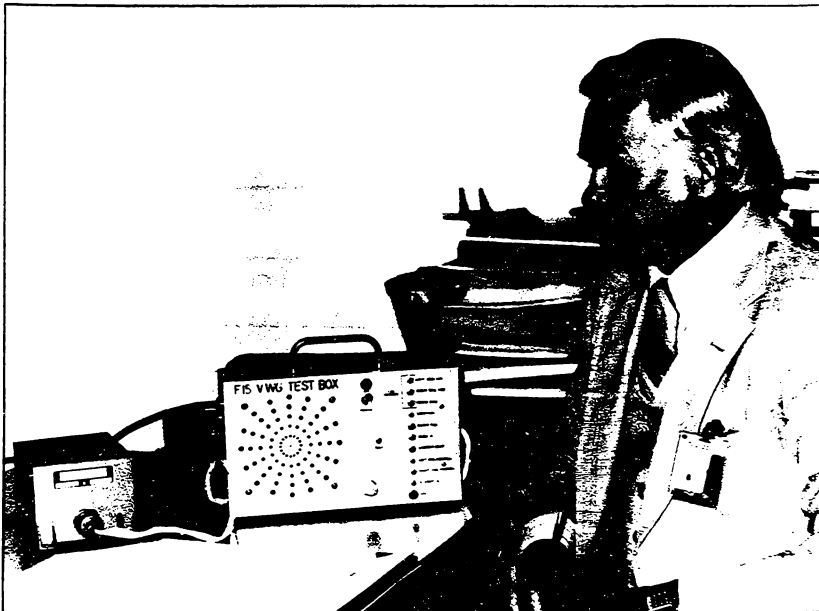
Co-author of this article, J. T. Johnston, with two units used in OWS test program. The smaller box on the left is the Voice Warning Generator as actually installed in the F-15 aircraft. It produces digitally synthesized voice warning signals associated with engine control, engine AMAD fire, fuel, landing gear, and over-G conditions. Larger unit is a voice warning test box containing switches, volume control, and speaker for evaluating quality of signals. Both devices were designed, developed, and fabricated by McDonnell Douglas Electronics Company.

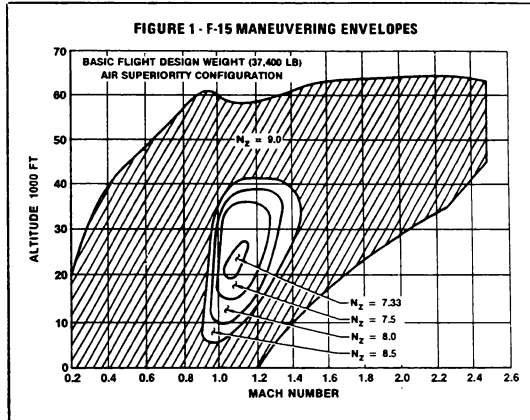
The new HUD display (Figure 2) is a dead giveaway; Current g's now share window 8 with maximum allowable g's. (Note the absence of decimal points and minus signs; we had to give them up to get it all in, but that's no problem in flight - if you can't tell the difference between 1.2 g's and 12 g's, you're already in trouble!) A word about the readouts. Current g's will often sit near 1 g, but not right on it. A

display of 09, 11, or 12 is not uncommon; beyond that warrants corrective action. As for allowable g's, we don't envision that pilots will fly around with one eye glued on window 8 to see what's permissible during ACM. Over a period of time and varied flight conditions, however, the readout will change in accordance with Figure 1; and pilots will inevitably develop a mental picture of their structural envelope. Allowable g's displayed are symmetrical, of course, not rolling g's.

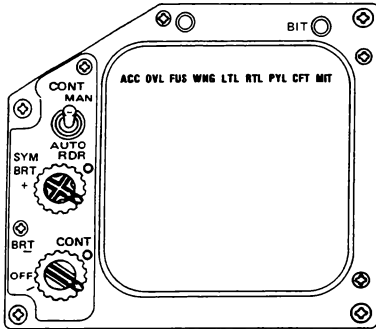
FIGURE 3 - VSD OWS DISPLAY COLUMN HEADINGS

- ACC = ACCELERATION - LOAD FACTOR
- OVL = PERCENT OF OVERLOAD
- FUS = FORWARD FUSELAGE
- WNG = WING
- LTL = LEFT TAIL
- RTL = RIGHT TAIL
- PYL = PYLON
- CFT = CONFORMAL FUEL TANKS
- MIT = MASS ITEMS

the same way airborne or whenever), what you'll see will probably look like Figure 3. In some rare instances, it may look something like Figure 4 or 5, with leftover data from maintenance action or a previous flight - we don't want to make this too easy!

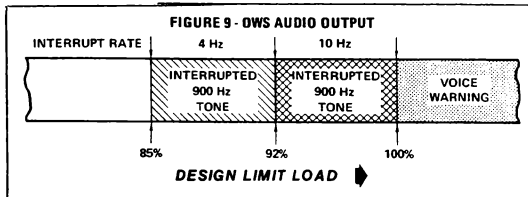
FIGURE 8 - SEVERITY CODES

Code	% Design Limit Load
0	85 TO 100
1	100 TO 110
2	110 TO 120
3	120 TO 130
4	130 TO 140
5	140 AND GREATER

voice warning is triggered if over 100% design limit load is reached (severity code of 1 or greater) and will say "Over g, over g."

Figure 6 shows the location of all possible data which can show up on the VSD. Line 1 will be a summary of the worst conditions seen during all the high g events of the flight (or previous flight, perhaps) - the highest load factor, overload percentage, and severity code for all reporting stations. Line 2 will be the most recent high g event recorded (85% design limit load or greater). The remaining lines are in groups of three and concern themselves only with a particular reporting area such as forward fuselage or wing. Speaking of severity codes, Figure 8 is a tabulation showing what the codes mean relative to abusing your bird. The

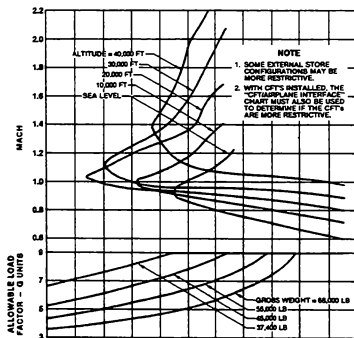
**FIGURE 1
F-15A/B/C/D
OWS SYMMETRICAL ALLOWABLE LOAD FACTORS**

Display of the allowable g's on the HUD is a tool to assist the pilot in using the system. It is a prediction of the g level where the aircraft structure will be loaded to 100% of the allowable limit load. This prediction is a fairly complex task and there is not always perfect agreement between allowable g's and the g level where the voice activates. The pilot would probably never notice this disagreement in flight; however, it could be seen when reviewing the HUD video tapes. *The tones/voice are based on actual flight conditions, not predictions and are the prime means of using the system and structurally protecting the airplane.* The tones are activated as a function of percent (85% 1st tone and 92% for the 2nd tone) of allowable limit load, not percent allowable g's displayed on the HUD. The allowable g's displayed on the HUD are generally reduced during asymmetric maneuvers. It is doubtful that a pilot could use this feature effec-

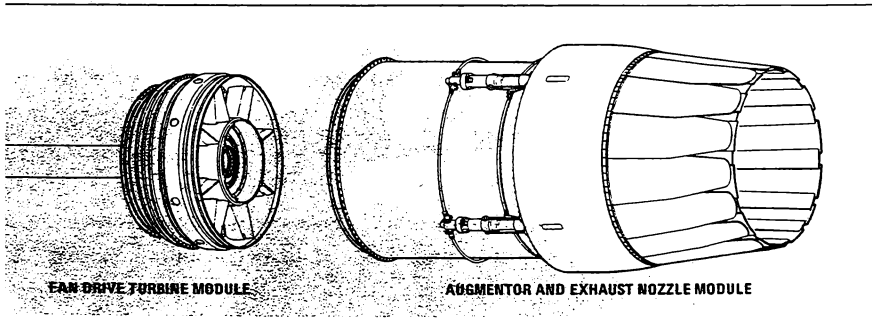
FAN DRIVE TURBINE MODULE

AUGMENTOR AND EXHAUST NOZZLE MODULE

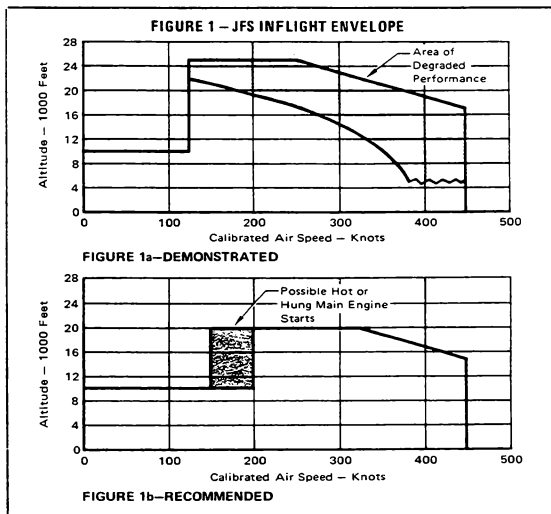
JFS performance during FCF's and rid yourself of *all* centerline equipment (including pylon!) during an actual emergency. You can, however, be aware of the envelope and aim for the conservative side. Figure 1b shows the envelope performance we recommend based on flight checks at St. Louis and Edwards AFB.

Figure 1a shows that at 17,000 feet and below, we are enjoying JFS operation out to 450 knots, a speed that should provide sufficient torque to

spool-up an engine from zero RPM with ram air alone. It did not seem practical to investigate JFS capabilities beyond this speed. On the slow side, if you can fly comfortably, the JFS can run. Even though age and wear can degrade JFS performance, thus lowering its airstart ceiling, we feel that 20,000 feet should be routinely attainable. A much more dramatic degradation is seen with any kind of centerline store, including a pylon alone; hence, the recommendation to clean off that station when you really need the JFS. An area of degraded performance is shown, rather than a hard line, because the variables of centerline store type and JFS condition make it impossible to accurately predict performance for any given combination.

Obviously, there are two generalized initial altitude conditions — either inside the JFS envelope or above it. With one engine in stagnation to support the hydraulic requirements of the flight control system and emergency generator, my choice would be to transition to a 220 knot glide, versus 300, 350, or whatever, as soon as the JFS envelope (Figure 1b) is reached and punch off ALL centerline garbage.

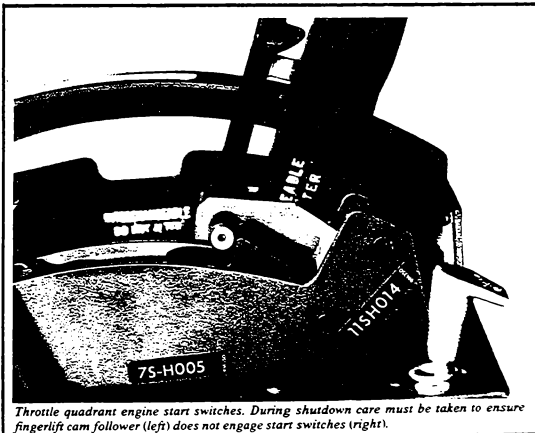
Throttle quadrant engine start switches. During shutdown care must be taken to ensure fingerlift cam follower (left) does not engage start switches (right).

use the JFS, be careful when shutting down a stagnated engine. Don't hold the fingerlift full up while moving the throttle full aft since that will activate the micro-switch, which causes the JFS logic to attempt to engage the JFS as soon as it is started. If engine RPM is 30-50% when the JFS attempts to engage, a "crash engagement" occurs which results in a sheared starter shaft. An engineering change has been proposed to solve the crash engagement problem, but until it is approved and incorporated, caution must be exercised.

If the start circuit is already energized and the engine RPM is above 30% when you start the JFS, you stand a good chance of shearing the CGB stub shaft. This is also true if you inadvertently actuate the start circuit while shutting down the engine with RPM above 30% and the JFS already running. In either case, if the shaft fails the JFS will accelerate to 100% and stay there. JFS restart capability for that engine has been lost.

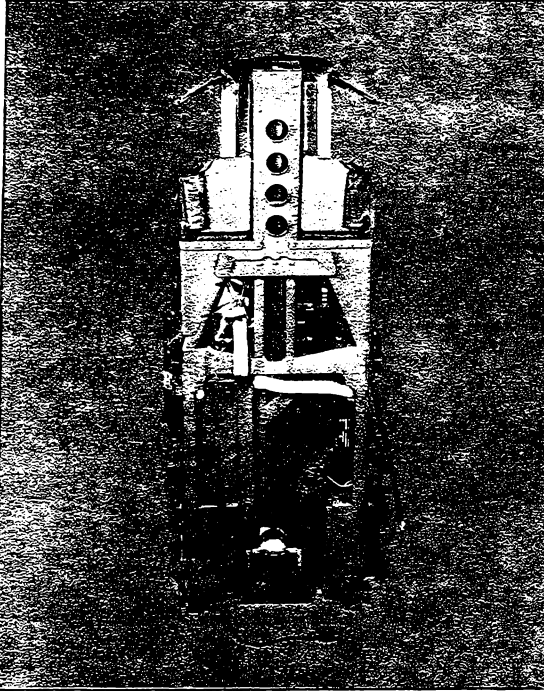
Rocker Catapult

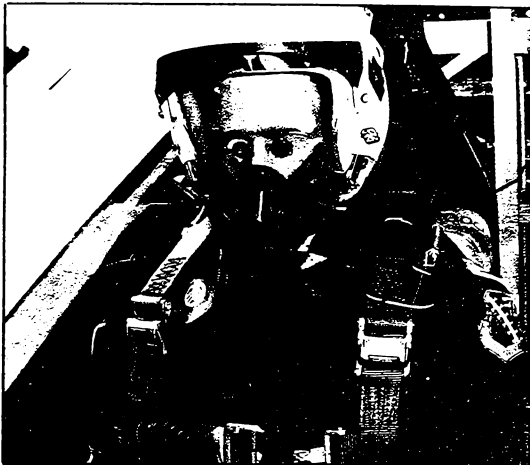
"Dummy" positioned in rear cockpit of TF-15 prior to first ground tests of canopy-off program. Helmet contained 15 sensors, and eye-mounted transducer was also used to measure impact pressures.

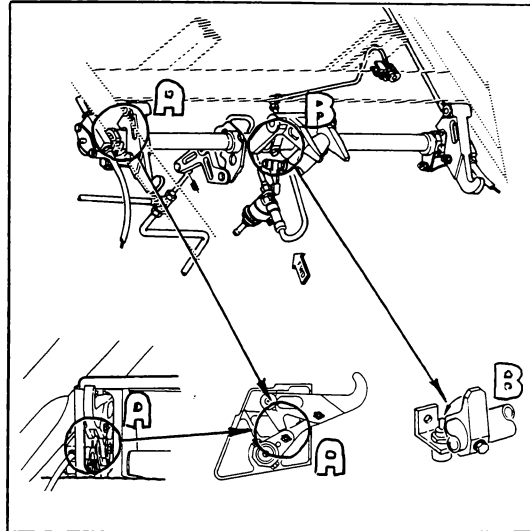
Top sketch circles two areas that were primary parts of Bald Eagle's canopy loss problem. (A) shows locking hook/overcenter link area where overcenter stop on either left or right side of canopy torque tube must be making contact to assure the mechanism is locked. The canopy lock position indicator switch (B) was misrigged (plunger bottomed out), preventing the mechanism from locking or from giving an indication that the canopy was unlocked.

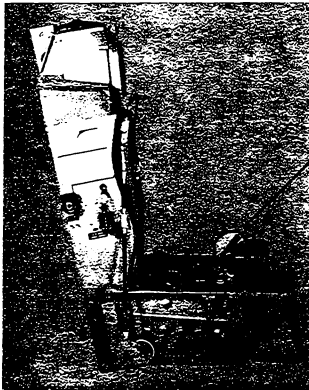
ACES-II SEAT SAFETY LEVER

Suppose — just suppose — that for some strange and sudden reason, you have decided to vacate your airborne Eagle via the ACES-II ejection system. You did remember, way back in Step 18 of your BEFORE TAXI checklist, to flip the Ejection Controls Safety Lever back to ARMED, didn't you? While it only takes a moment — now or then — to move the lever, spare moments are in short supply when you're at 2000 feet and out of luck. Do your things at the right times and avoid what could be one of life's most embarrassing moments, where you find yourself all dressed up and no way to go!

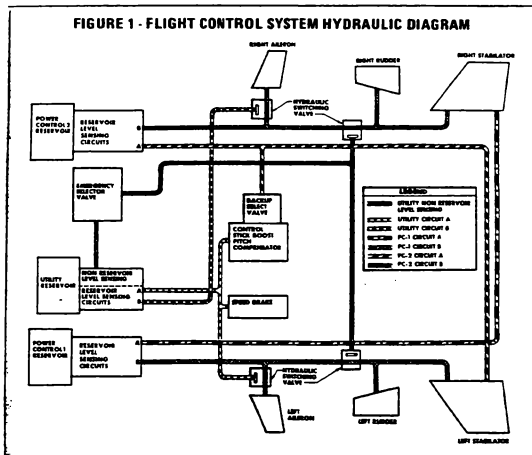
Referring to the hydraulic system block diagram (Figure 1), you can see which hydraulic system powers which control system actuator. The PC-1 system powers the left side of the aircraft plus both stabilator actuators. The PC-2 system powers the right side of the aircraft plus redundant power to both stabilator actuators. The Utility hydraulic system is a backup system and

can provide power to the entire control system. The PRCA and ARI receive their hydraulic power from the Utility system with PC-2 as a backup. What this all adds up to is a system that can be safely flown and landed after a total loss of any two of the three hydraulic systems.

The F-15 control system is powered by three separate hydraulic systems: Power Control One (PC-1) driven by the left engine, Power Control Two (PC-2) driven by the right engine, and a Utility system which contains two pumps, one on each engine. Each system is provided with a switchover valve which senses system return pressure. If pressure falls below a pre-selected value, required pressure is regained through a switch to another system.

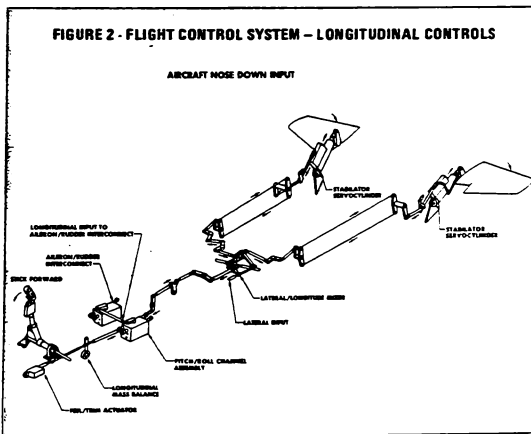
Outside of the PRCA the pitch linkage is fed to a "mixer" linkage where it is combined with roll inputs. These give the stabilator inputs reflective of either pitch or roll. The F-15 stabilators are used collectively for pitch and differentially for roll.

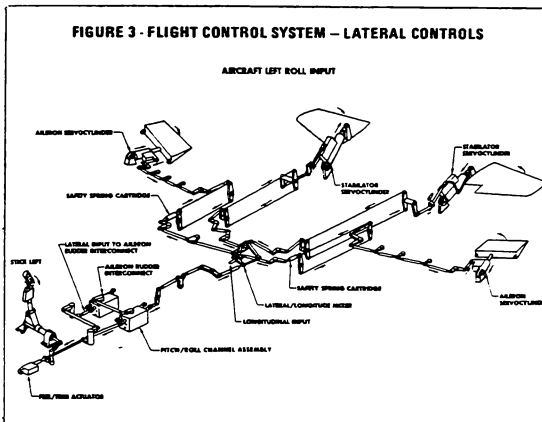
Roll output of the PRCA is hydraulically boosted for the same reasons as is pitch output. The mixer linkage, referred to earlier, receives a lateral input which is transmitted to the ailerons and as differential signals to the stabilizers.

A safety spring is provided, allowing continued roll control operation

should one side become totally jammed. The aircraft can be safely flown and landed with one aileron and differential stabilizer control. Aileron surface power is supplied by conventional hydraulic actuators.

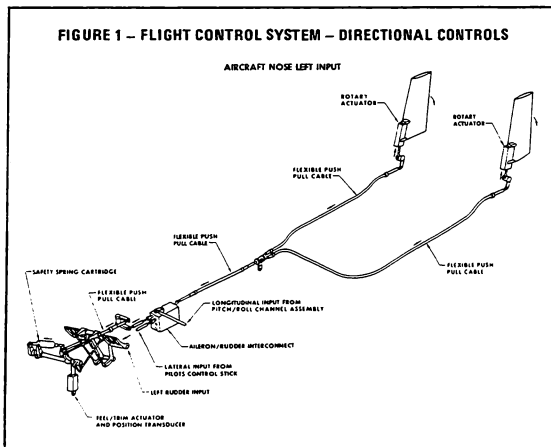
The Yaw Trim switch signal goes to the CAS roll/yaw computer where the switch commands are amplified by transistor relay drivers. This output is supplied to the yaw feel trim actuator, picking up relays within the actuator, powering its motor, and driving the actuator to a new position. Simultaneous with actuator travel, electrical signals are generated by a pair of Linear Voltage Differential Transform-

ers (LVDT). These signals are fed back to the CAS roll/yaw computer and are used for three distinct functions. The signals:

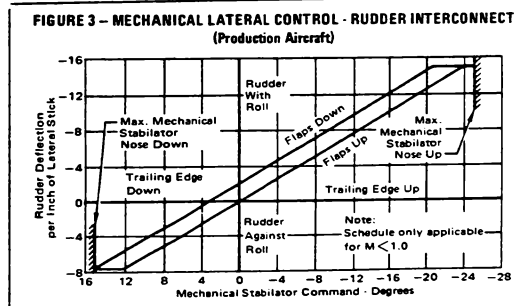
The Flaps Down shift valve modifies the schedule allowing more rudder, sooner, with flaps down than is available through the flaps up schedule. Looking at the graph (Figure 3), note

that with flaps up and 10 degrees nose-up stabilator, you can expect 6 degrees of rudder per inch of lateral stick (two inches of left stick equals 12 degrees of left rudder). Likewise, with flaps down and 8 degrees of nose-down stabilator, you'll get 3 degrees of rudder per inch of lateral stick (two inches of left stick equals 6 degrees of right rudder).

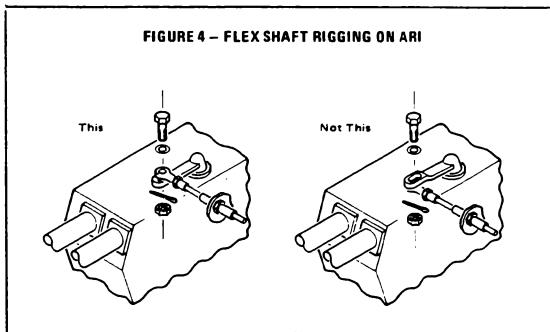
FIGURE 4 - FLEX SHAFT RIGGING ON ARI

The control valves, operating from Utility hydraulic power, provide a rotary motion rather than the conventional extension or retraction of a hydraulic ram. Because of this design, the actuator requires no additional bellcranks or other linkages to change motion direction. Each actuator forms an integral part of the rudder hinge; the actuator is a self-contained unit and positions the rudder control surface in response to pilot pedal commands

pitch information between the PRCA and ARI. Kinks or bends in this shaft cannot be tolerated and are cause for cable replacement.

twist it any more than necessary. When connecting cables to bellcranks, strive for the best alignment possible by juggling clamps where necessary. On later delivered airplanes (beginning at about airplane 51), special adjustable support brackets will be available to assist in careful cable alignment. With cautious handling and installation, linkage friction and rudder surface hang-up will be minimized. ■

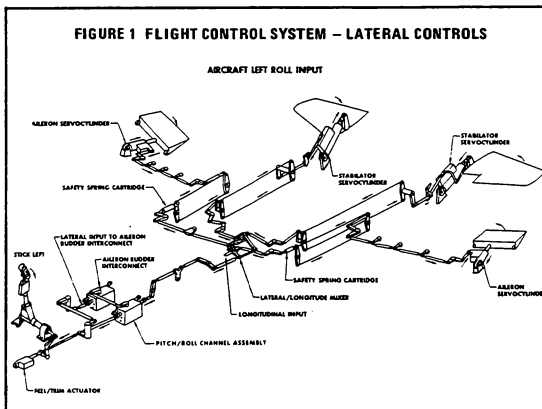
As it leaves the lateral feel trim actuator, the linkage takes two paths. The first path travels to the ARI on the

right-hand side of the airframe. As we discussed in Part II of this series, this input supplies the lateral intelligence to the ARI. The second path continues down the left side of the aircraft to the PRCA which is the "brains" of the F-15 mechanical control system. Figure 2 is a block diagram of the PRCA and shows the data flow within the roll channel of the PRCA.

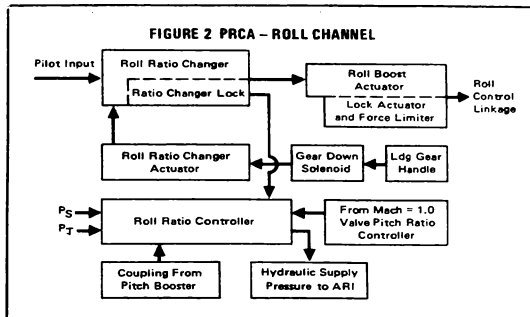
Roll Ratio Changer — The roll ratio changer, within the PRCA, contains the dual mechanical linkage required to vary the stick-to-aileron/differential stabilizers gearing at a ratio of 4:1. Figure 3 explains how a parallelogram ratio changer does its work.

Diagram I shows the ratio changer actuator at maximum ratio as indicated by distances D to A and E to C being identical. Pilot stick inputs to point A displaces the output B by the same amount; that is, a 1:1 ratio. In diagram II, note that the ratio changer has been fully extended, placing pivots E and C over one another. Stick inputs to point A can rotate the linkages about E and C with only a small amount of output displacement for a ratio of 4:1. Diagram III shows an intermediate ratio. In this case, pivot E of the ratio changer actuator can be called upon to vary the ratios as dictated by the air data information fed to it, or by longitudinal control system position.

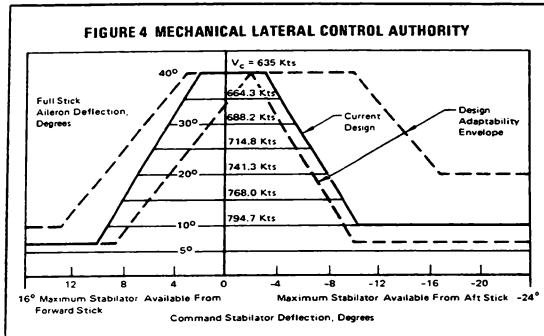
The only situation in which the ratio controller cannot command the ratio changer actuator to move is when the landing gear handle is positioned to extend the gear. During the early days of F-15 flying, it became apparent that during crosswind landings more than the available roll power was needed to keep the upwind wing from rising. As previously stated (and shown in Figure 4), when the aircraft is slowed to land and the stick is either trimmed or held

aft, roll power is "washed out" (the amount of aileron available with full stick is reduced). The problem was resolved by adding a solenoid valve to the ratio changer actuator which drives the ratio changer actuator to maximum ratio when the landing gear handle is placed in the down position. All production PRCA's have this feature so it is not possible to check aileron/differential stabilizer washout on the ground without putting the gear handle up (with hydraulic pressure

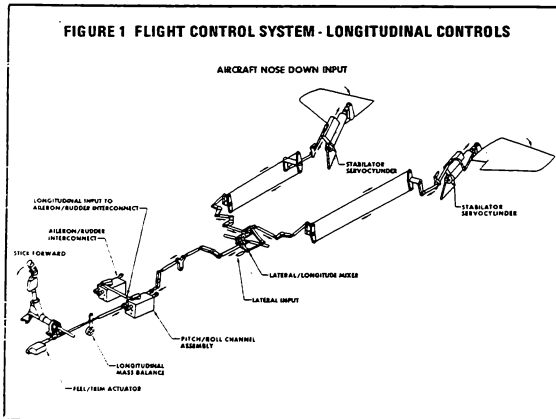
To begin with, let's break the PRCA pitch channel into its components (Figure 2) and see how each affects the longitudinal controls. The input rod offers two linkage paths with the main path tying directly into the ratio changer linkage, and a second input being supplied to the Load Factor Sensor portion of the Pitch Trim Controller.

Pitch Ratio Changer — The pitch ratio changer utilizes dual redundant parallelogram linkage identical in operation to the roll ratio changer described in our last DIGEST article on lateral controls. The only operational

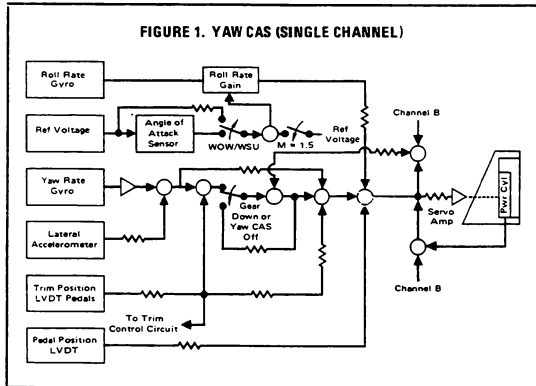
Sideslip Control and Damper - Precise sideslip control is provided during maneuvering by the yaw CAS. Referring to the yaw channel block diagram (Figure 1), you'll see a Rudder Pedal Position Linear Voltage Differential Transformer (LVDT). As the pilot applies force to the pedals, the mechanical system begins to deflect the rudders. At the same time, the pedal position LVDT generates an electrical signal. As the aircraft responds to the pedal input, the yaw rate gyro and the lateral accelerometer will sense this motion. Their blended signals are

compared to the pedal position LVDT signal within the Roll/Yaw Computer and the resultant signal output either adds or subtracts rudder control surface deflection as needed to obtain the proper response. Likewise, this combination of signals directs the servo amplifiers to deflect the rudder power cylinder and rudder control surfaces the correct amount and direction to dampen any unwanted yaw disturbance.

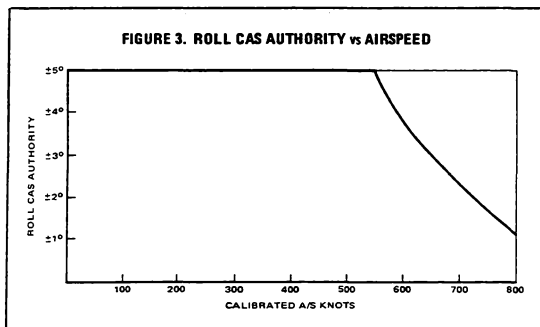
Additional roll CAS limiting is required to reduce the roll/yaw coupling for negative angles of attack, and at large positive angles, to minimize the adverse yaw. This provides an equivalent to the "aileron washout" function of the mechanical control system which was discussed in an earlier article. The angle-of-attack limiting is subtracted from the airspeed schedule as indicated in Figure 4.

No roll CAS is desired at angles of attack above 20 degrees. This prevents the adding of pro-spin controls through uncommanded pilot-induced CAS inputs, and roll damper inputs, at the higher angles of attack. The angle-of-attack schedule is switched

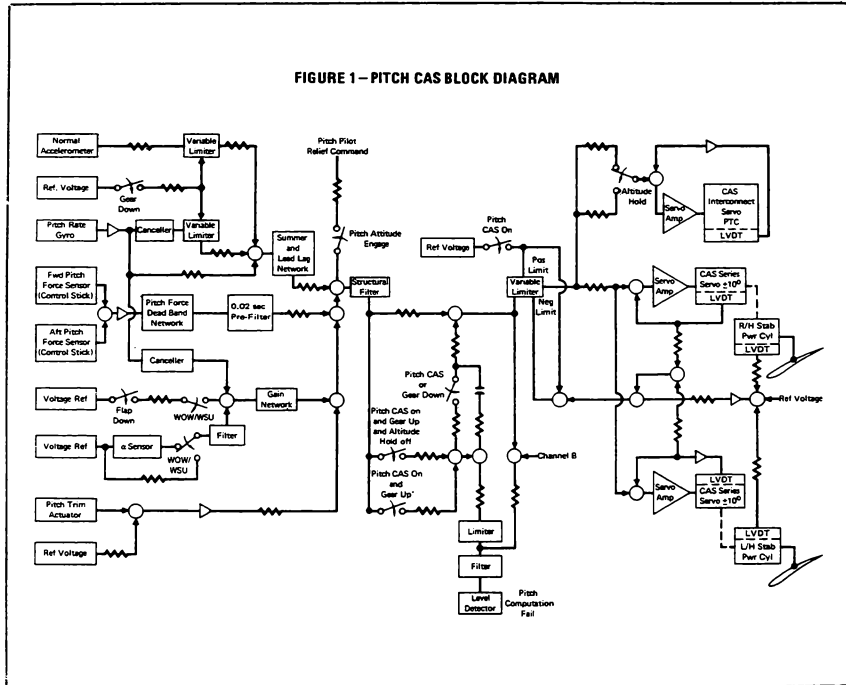
FIGURE 1 - PITCH CAS BLOCK DIAGRAM

Pitch trim signals are also fed into the pitch CAS to tell the system what trim value the pilot requires. If this trim signal were not present, any manual retrim selected by the pilot

would be defeated by the CAS returning the aircraft to the original trim position. Pitch CAS commands are also used to deflect the CAS interconnect servo, located in the Pitch Trim Compensator module of the PRCA. These commands serve two functions. First, they insure that the mechanical and the CAS systems are tracking each other, minimizing any disagreement that may exist if the pitch CAS disengages and the mechanical system takes over. The second feature allows the CAS interconnect servo to carry an offset from null, allowing the CAS series servo (within the stabilator power cylinder) to maintain its full ± 10 degree authority.

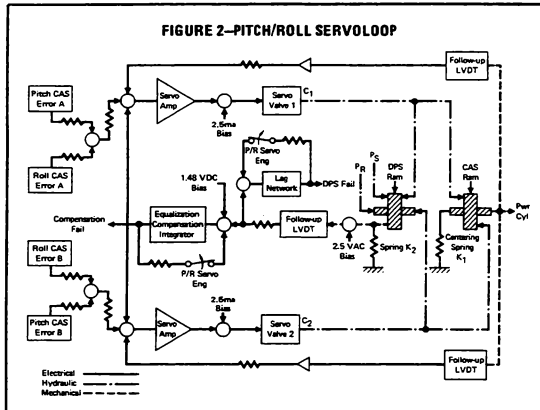
FIGURE 2—PITCH/ROLL SERVOLOOP

Due to the high authority of the pitch CAS (± 10 degrees), failure transient control is provided and its operation can be understood by referring to Figure 2. If a failure occurs, one servo valve will be driven hardover by full supply hydraulic pressure and the CAS ram will begin to displace in the direction of the failure (note that each servo valve is biased so that null failures within servo amplifiers or servo valves will result in hardover servo control pressure). As the CAS ram begins to displace, an error is generated at the input of the remaining servo amplifier. This causes its servo valve to establish a counteracting force on the ram. Since both servo valves are connected to the same hydraulic source, the resultant forces seen by the CAS ram are opposite and equal, causing the ram to stall. This condition is called "force fight." The CAS ram will then begin to center at a 0 to 1 degree per second rate determined by spring K1. Small mistrack and deadband errors below the equalization compensation networks are dealt with by the "force fight" technique and result in small engage transients. These are too small to cause aircraft displacement and can be ignored.

Looking again at Figure 2, note the

differential pressure sensor (DPS) ram and its associated connections. With no failures, pressure C1 and C2 on the right hand side of the DPS ram are equal and balance the combined pressures of $P_s + P_r$ and spring K2 on the left side of the DPS ram. In this condition, equilibrium exists (no motion of ram) and the equalization compensation integrator output is zero (CAS remains set, no failures).

If pitch CAS component failure occurs, such as described in the "force fight" explanation, the equilibrium of pressures $C1=C2$ on the right side of the DPS ram are upset and the DPS ram begins to drive slowly harderover. The DPS, LVDT signal is fed to the equalization compensation integrator which starts to slew in a direction to reduce the LVDT signal to zero. If the integrator signal has not reached zero in three seconds, a shutdown pulse is generated by the CAS and both stabilator ± 10 degree series servo shutoff valves are deenergized. Controlled orifices and spring-controlled locks center the CAS and DPS rams.

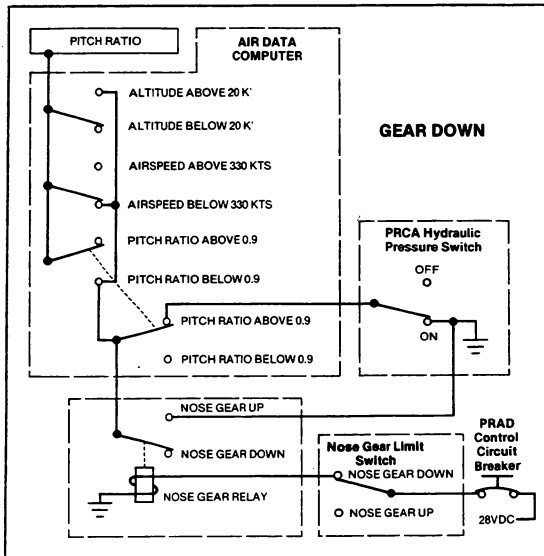
A continual monitor of pitch ratio would require some sort of computer but then if a problem came up, you wouldn't know if it was caused by the monitor or the pitch ratio. Instead of building a monitoring computer, a relatively simple logic system was devised as a check to make sure the pitch ratio is not grossly mispositioned in the critical areas of flight — low altitude, high speed, and landing. This logic can best be understood by leading yourself through the two diagrams which show the circuits for gear down and gear up conditions. The logic goes like this: If you can't work your way from the "PITCH RATIO" box through the maze and get to "ground" (\oplus) you have a condition that will illuminate the "PITCH RATIO" light.

This "short cut" logic does lead to one small problem wherein the warning light can lie to you if you are low and fast with landing gear down. With the landing gear down, the primary purpose of the warning circuit is to advise if the pitch ratio is less than 0.9, indicating reduced control authority for landing. Below 20K and at speeds around 220 to 300 kts, the pitch ratio begins to schedule down below 0.9; thus if the landing gear is down at

these conditions, the light comes on. Pitch ratio will read between 0.9 and 0.75. In this rather limited speed range with gear down, the pitch ratio caution light can illuminate, but the system is working as designed. So, if you have a habit of flying fast (260 to 300 kts) with the gear down, you may get an occasional objection from the pitch ratio light.

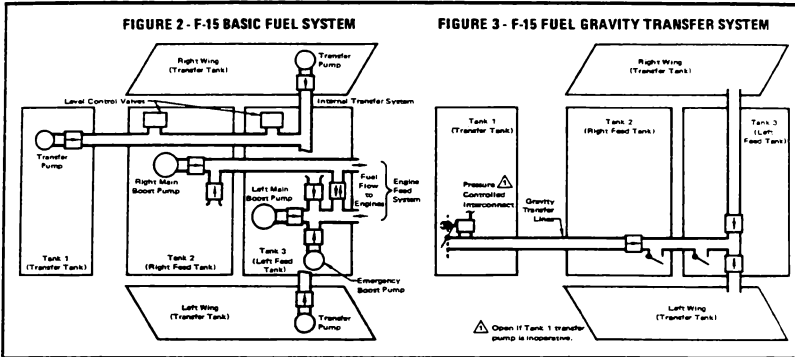
To understand the Eagle's fuel gravity transfer system, a brief look at its basic fuel system is needed. Fuel is carried in five internal tanks, as shown in Figure 1. Feed tanks 2 and 3, located near the center of the aircraft, supply fuel directly to the engines. Fuel is transferred to these feed tanks

from three transfer tanks, one located forward of the ammunition container and one in each wing. A continuously operating transfer pump in each of these tanks maintains "full" feed tanks (except for brief periods of high fuel consumption). A schematic of this system is shown in Figure 2.

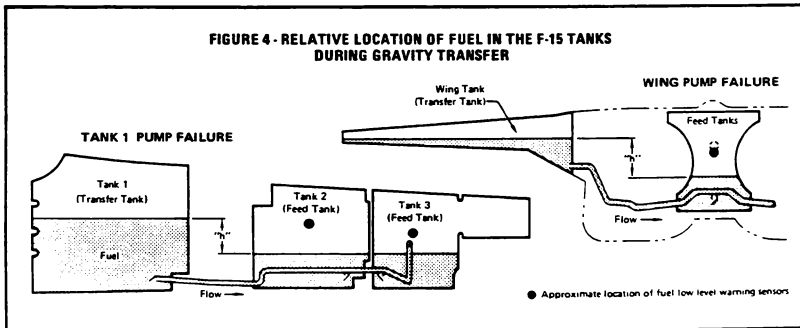
FIGURE 5 - EFFECT OF ENGINE FUEL FLOW AND AIRCRAFT PITCH ATTITUDE

(Tank 1 Transfer Pump Failure)

The primary factors which affect the operation of the system are "engine fuel demand" and "aircraft pitch attitude." Figure 5 shows how fuel availability is affected by engine fuel demand and aircraft pitch attitude for a pump failure in Tank 1. Figure 6 shows similar information for a wing pump failure. These two figures combine to show that for any transfer pump failure, maximum fuel is available when the engine fuel flow is limited to 3500 PPH/ENG or less, and aircraft pitch attitude is maintained between 3° and 7° nose-up. Transient throttle movements and attitude variations outside these bands are acceptable provided the aircraft is returned within these boundaries prior to feed tank depletion.

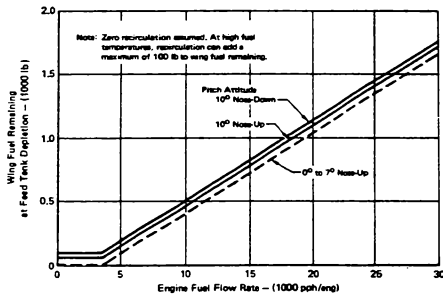
FIGURE 7 - TYPICAL ENGINE FUEL FLOW REQUIREMENTS

(Air superiority configuration)

Figure 7 shows that the 3500 PPH/ENG limit can be maintained during cruise, loiter, or landing. In addition,

cruise, loiter, and landing attitudes are normally within the 3° and 7° nose-up limit.

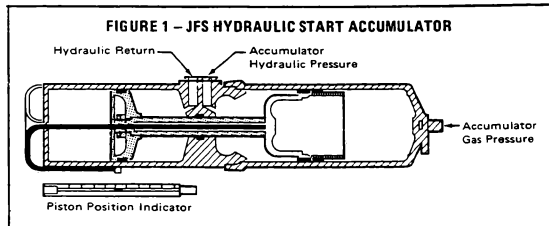
The JFS hydraulic start system major components are two hydraulic start accumulator bottles, two piston position indicators (attached to the accumulators), two compressed gas pressure gauges, all located behind Doors 88L/89L; and a hydraulic start motor mounted on the Central Gearbox (CGB). The accumulator bottles are of the cylinder and piston arrangement (see Figure 1) with nitrogen gas on one side of the piston and hydraulic fluid on the other side.

The Piston Position Indicator (PPI) shows the percentage of fluid, by volume, in the bottle. Gas "precharge" is the initial amount (pressure) of gas available to be compressed when there is no fluid (zero PPI) in the bottle. Gas pressure is read on the two gauges inside Door 89L: the forward gauge measures pressure in the top accumulator, the aft gauge measures the pressure in the bottom one.

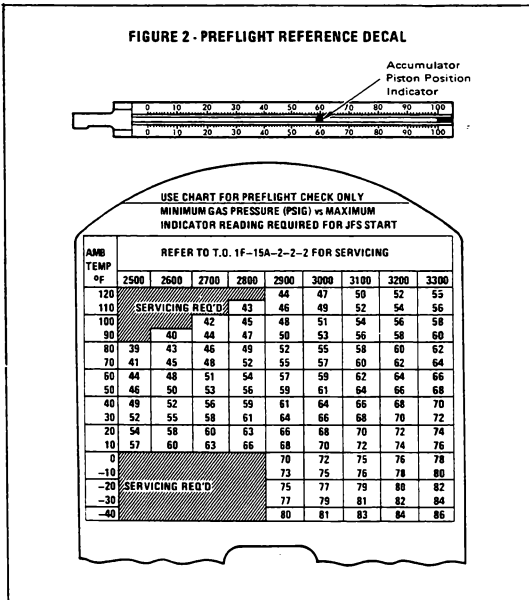
FIGURE 2 - PREFLIGHT REFERENCE DECAL

The T.O. chart and instructions must be used to service the system, but a handy preflight reference decal is available on the inside of Door 89L (or on the accumulators in some earlier aircraft). This decal, represented in Figure 2, can be used as a quick reference to determine if your JFS system is properly serviced. Look from the left side of the decal (ambient temperature) horizontally until you come to the block containing the number corresponding to the value read on the PPI scale. Then read vertically and you will find the minimum gas pressure required for JFS start. The photo on page 10 shows a properly serviced system at 55°F: PPI reading = 60, gas pressure = 3000 PSI.

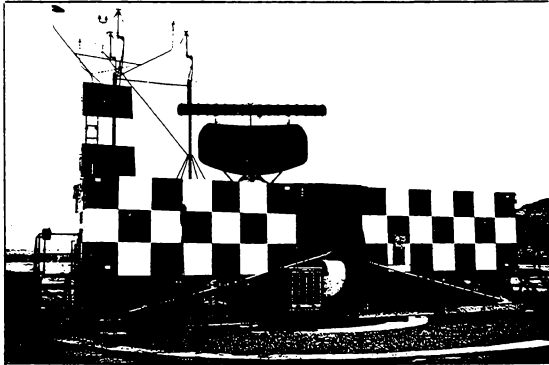
GCA radar at Nellis AFB. Located between the parallel runways and approximately 350 meters from the taxiway, its frequency is 2.8GHz and power output is 500KW.

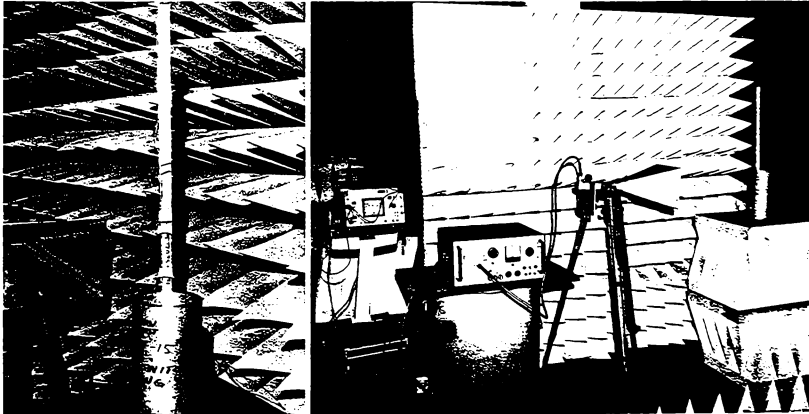
Lab set up used to simulate failure mode of WOW switches. A NARDA POWER PULSER excites standard gain horn, in the frequency of 3-5 GHz, which radiates on the simulated strut and WOW switch. Radar Absorbing Material (RAM-ECCO-SORB) is in the background.

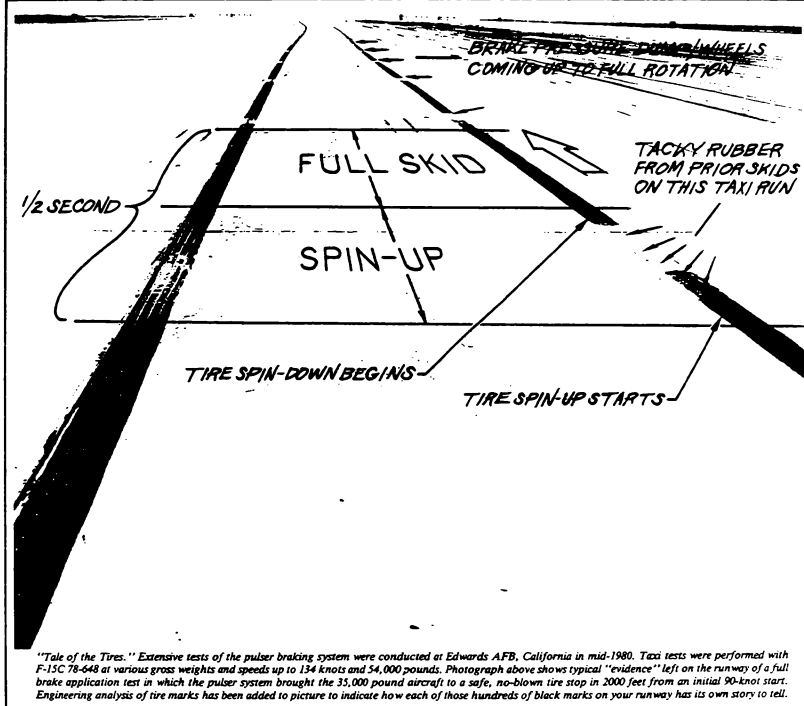
"Tale of the Tires." Extensive tests of the pulser braking system were conducted at Edwards AFB, California in mid-1980. Taxi tests were performed with F-15C 78-648 at various gross weights and speeds up to 134 knots and 54,000 pounds. Photograph above shows typical "evidence" left on the runway of a full brake application test in which the pulser system brought the 35,000 pound aircraft to a safe, no-blown tire stop in 2000 feet from an initial 90-knot start. Engineering analysis of tire marks has been added to picture to indicate how each of those hundreds of black marks on your runway has its own story to tell.

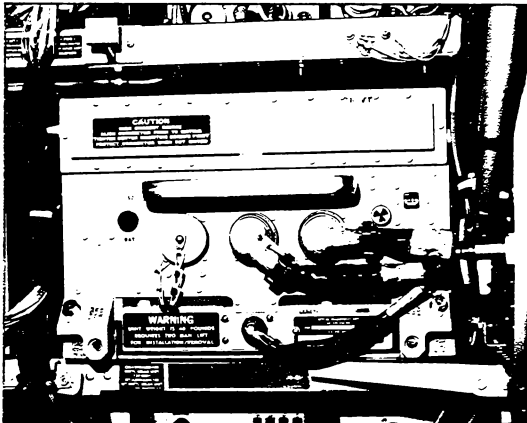
Inertial Measurement Unit (IMU) installed in Door 3R area. Note cautions and warnings.

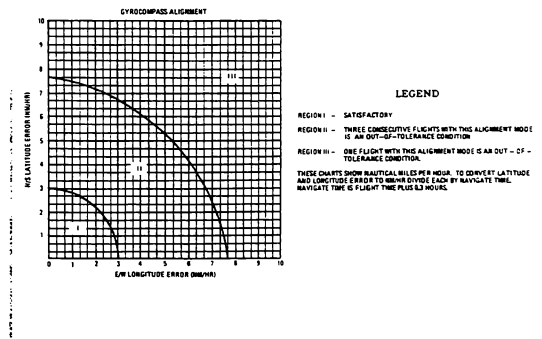
Figure 1 - Gyrocompass alignment criteria.

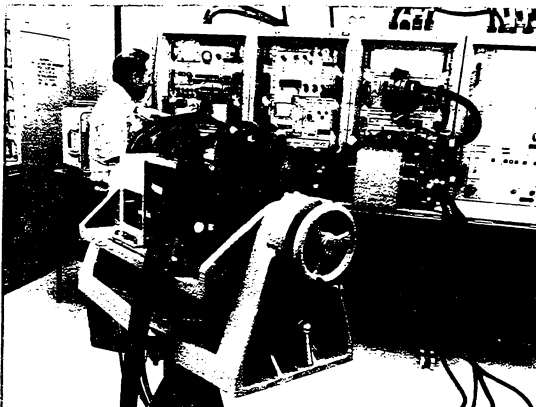
AIS computer test station used to test the INS — Inertial Measurement Unit mounted on attitude simulator in foreground.

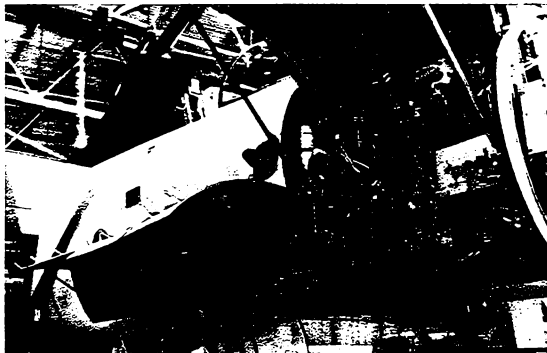
Inertial Measurement Unit (IMU) is located behind door No. 3R in right side equipment bay No. 2. All three current versions of IMU are interchangeable in aircraft, but have different alignment characteristics as noted in Table I.

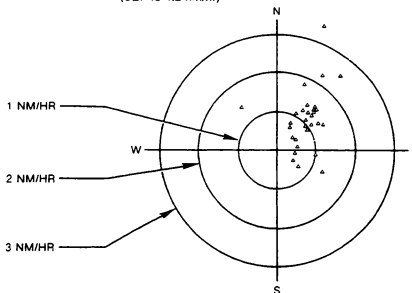
FIGURE 1 — PRESENT POSITION CEP (30 TYPICAL FLIGHTS)
(CEP is 1.2 nm/hr)

Note:
CEP is derived from radial error rate (RER) for each flight —

$$RER = \frac{\sqrt{[(LATITUDE ERROR)^2 + (LONGITUDE ERROR)^2]}}{NAVIGATION TIME} \text{ nm/hr}$$
 (error in nautical miles; navigation time in hours (time in NAV Mode))

The recommended and the most accurate alignment is the full GYROCOMPASS (GC) mode. This mode has a specification accuracy of 3 nm/hr CEP, but data taken at MCAIR shows a 1.2 nm/hr CEP for production acceptance flights. After switching to the GC align mode, accurate present position must be entered (desired accuracy 0.1 arc minutes/600 ft). Alignment completion is signaled by a flashing ALN light. For the earlier versions (-23/-24), the indication is a change from a steady light to a flashing light. For the latest version (-25), the indication is a change from a steady light to a slow flashing light followed by a fast flashing light. The indication shall occur in approximately 10 minutes.

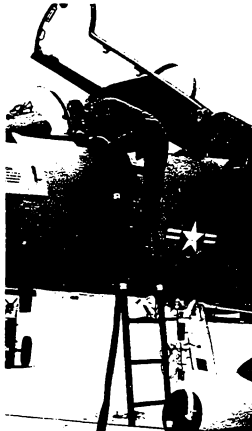
FLIGHT LINE MAINTENANCE

- **IMPROVE COMMUNICATIONS** (with pilot, debrief, and AIS personnel)

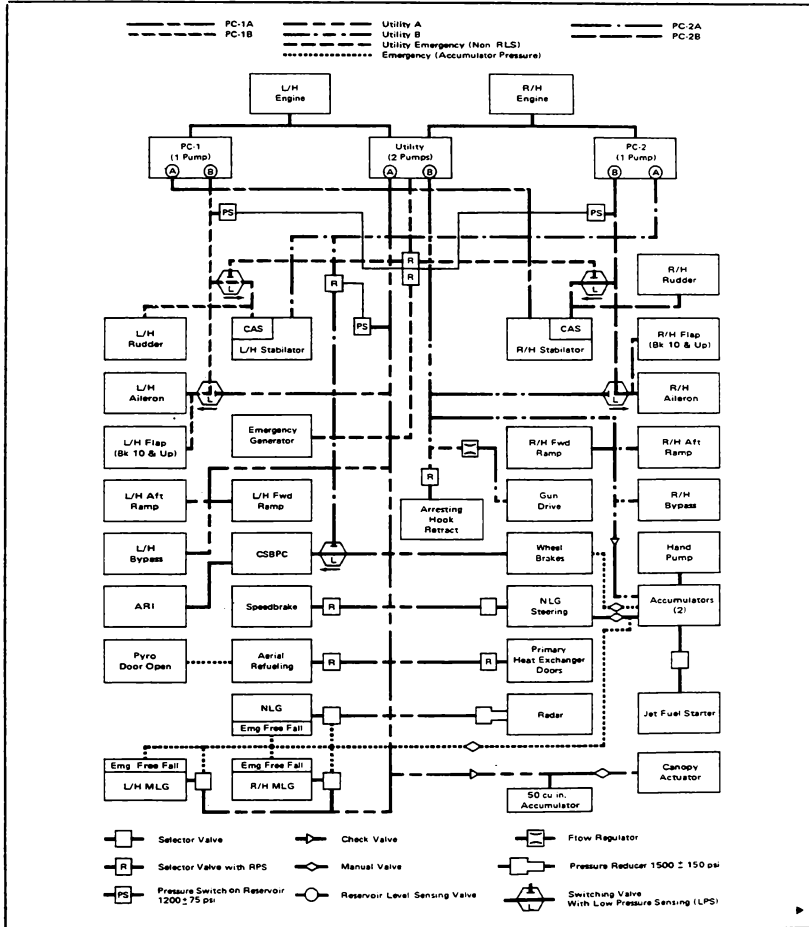
These valves allow the normal operating pressure from the "B" RLS circuits of both PC-1 and PC-2 to pass directly through the switching valves to the left and right ailerons, to one side of each tandem stabilator, and to each rudder. Should a "B" circuit lose

pressure for any reason (leak, pump failure, etc.), the switching valves will move to a test position to assure that the system downstream of the switching valve is intact. If system integrity is verified, the Utility system will be switched into the downstream flight control actuators. This test position prevents loss of Utility oil should the break be downstream of the valve.

Another new type of hydraulic component found in the F-15 is a "switching valve." Four of these are used to further improve the survivability of the primary flight control sys-

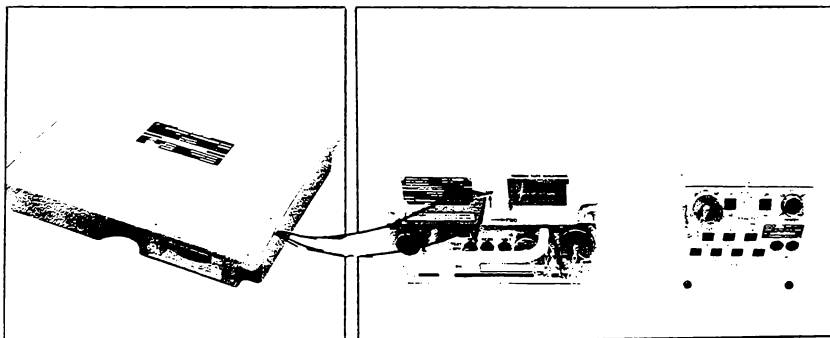
Tape cassette (left) records twenty-one flight data points gathered by the multichannel Signal Data Recording Set/SDRS (center). The Exceedance Counter Set (right) records positive and negative "g" loads.

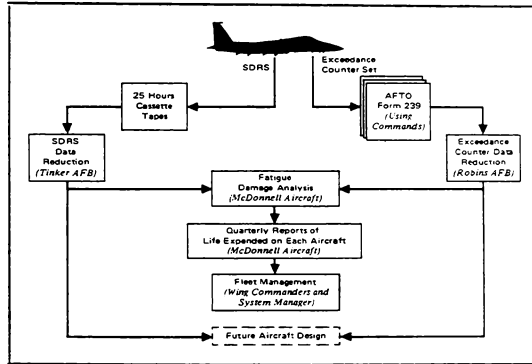
F-15 Fatigue Tracking Program (ASIP)

Damage estimates for all aircraft are made using a computer program which determines and totalizes the damage for each maneuver. The data fed into the program are a time sequence of stresses applied to each of several fatigue-critical locations. For
