A Crewman's History of the McDonnell...

F-15 EAGLE

**Volume II
(Technical)**

(REPRINTS FROM MCAIR PRODUCT SUPPORT DIGEST)

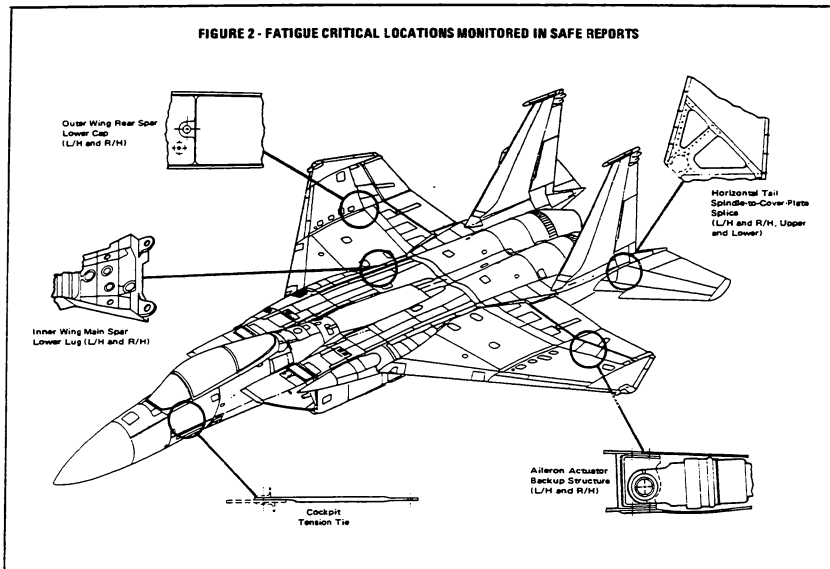
FIGURE 2 - FATIGUE CRITICAL LOCATIONS MONITORED IN SAFE REPORTS

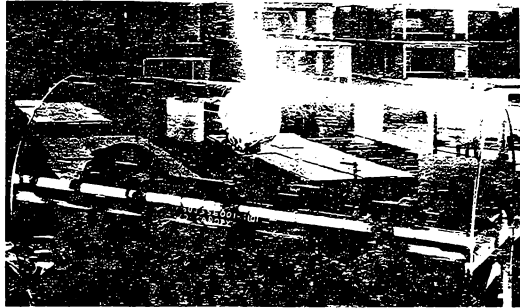
Figure 3. Voltages as high as 1.4 megavolts and currents as high as 200,000 amperes failed to puncture simulated canopies.

It is believed that canopies can be punctured by lightning with the possibility of pilot shock; however, we have never seen reports of this being a problem. Figure 3 shows a laboratory experiment on a simulated canopy. In the F-15 program we have performed extensive tests on actual and simulated canopies using artificial lightning. Neither a thin canopy mockup or the actual F-15 canopy could be punctured with simulated canopy strikes using voltages as high as 1.4 megavolts and currents as high as 200 thousand amperes. There have been reports of flash-blindness from lightning (temporary in most cases).

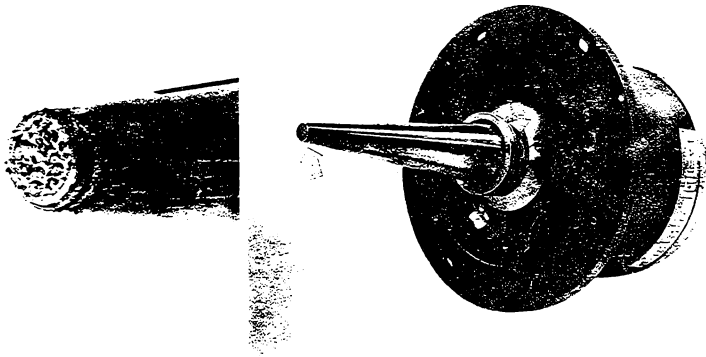
Figure 4. Evidence of a lightning strike is clearly shown on this F-4 angle-of-attack transmitter. On the right is an illustration showing three points where lightning attached to the unit. The illustration to the left shows an enlarged view of the damaged probe tip.

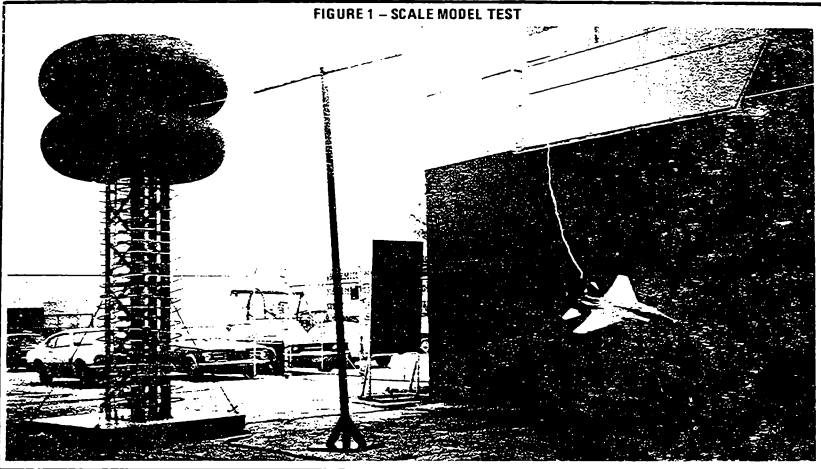
FIGURE 1 – SCALE MODEL TEST

Attach point tests are performed many times, and the model is changed to meet projected flight conditions including clean aircraft, with and without stores, and upright and inverted attitudes, until all strike points are known.

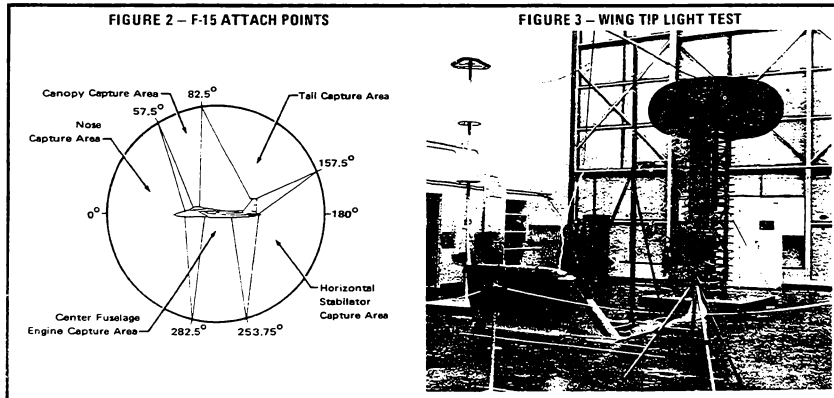
FIGURE 2 – F-15 ATTACH POINTS

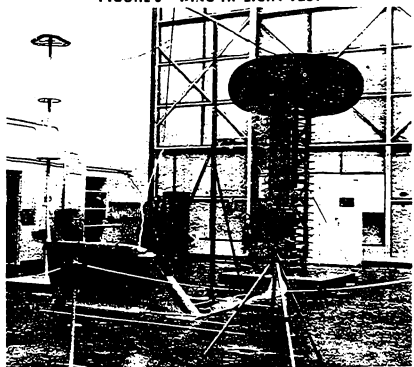
FIGURE 3 – WING TIP LIGHT TEST

• **Lights** - Since our primary lightning protection goal is to keep current flow outside the aircraft, and since MIL-B-5087 "Bonding, Electrical, and Lightning Protection for Aerospace Systems" states that "lightning discharge current carried between aircraft extremities shall not produce voltage within the vehicle in excess of 500 volts," lightning arrestors were install-

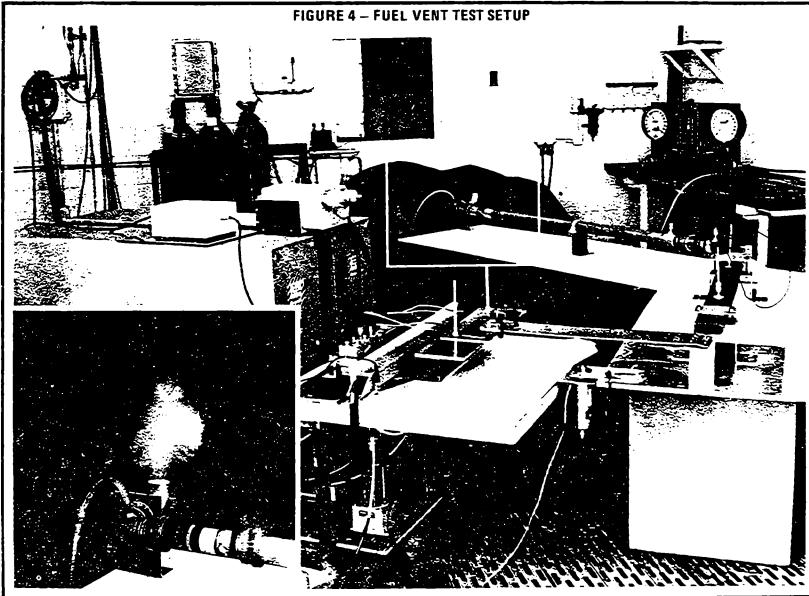
FIGURE 4 - FUEL VENT TEST SETUP

- **Fuel System** - In the original design, a flame arrestor was installed in the fuel vent and dump line. Foam was installed in the wing fuel cells for explosion suppression because it offered the most effective lightning protection when considering cost and weight. The external fuel tank was designed with adequate skin thickness and bonding to exclude internal sparking. When we got into the qualification tests we found that the previously installed flame arrestor (Figure 4) had to be lengthened to suppress the high-velocity flame front resulting from a lightning strike. In addition, we found sparking in the interface between the aircraft and the tank (this was caused by an electrical path other than the designed lightning current path). To eliminate this, we investigated and put into use a plastic (Valox 310) air inlet and fuel outlet probe which eliminated the tank-to-aircraft interface sparking. Figure 5 shows the metal probes and arc points (arrows) as well as the Valox probes now in use.

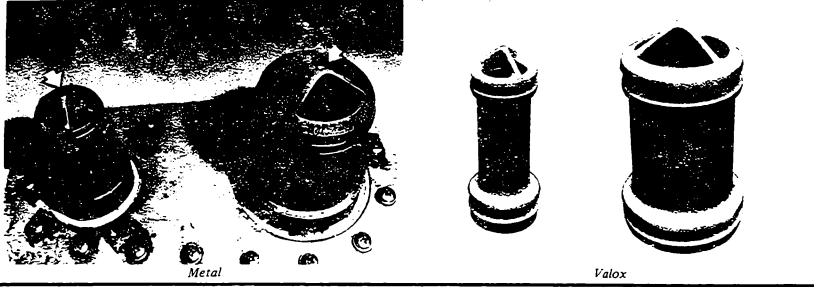
FIGURE 5 - EXTERNAL TANK FUEL AND AIR PROBES

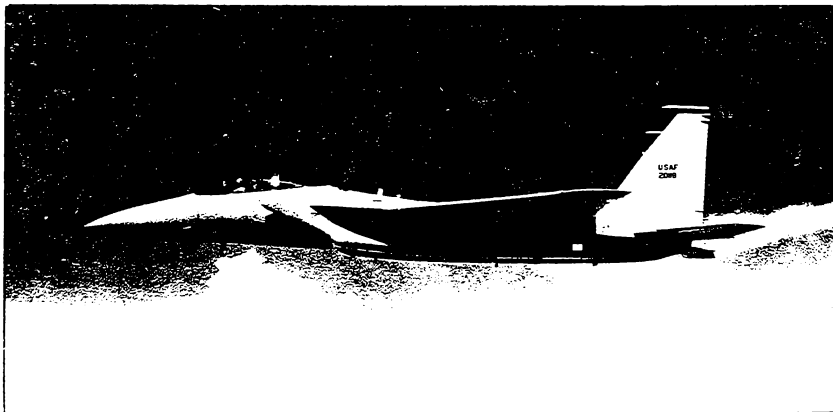
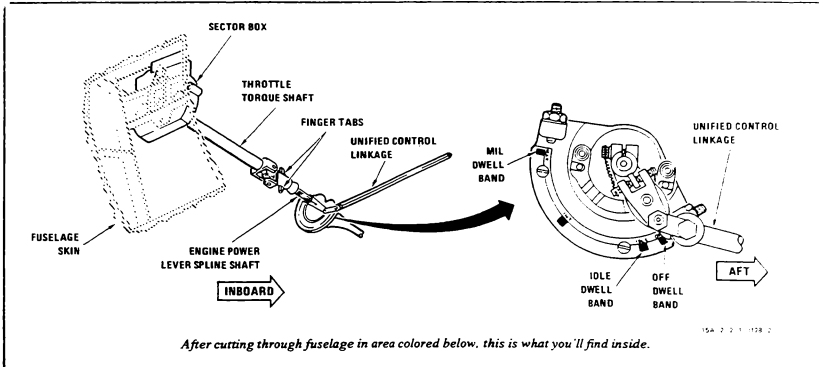
Normal access to this control is through Door 113L on the bottom of the aircraft, but assuming the door is closed (70 fasteners to open) or the airplane has landed gear up with the door in the dirt, the only way to get at the UC lever is breaking or cutting through the fuselage at the approximate spot circled on the photograph below. After gaining access, reach in, pull the finger tabs on the throttle torque shaft quick-disconnect toward you and turn upward to "open" (this disconnects the throttle shaft from the engine power lever spline shaft which allows the UC linkage to be moved). Then pull the UC linkage full aft and hold it there until the engine stops.

Simple, right? No, but it can be done. This method is obviously for an emergency situation, but "in extremis" is no time to be locating this spot on the airplane. If you happen to have an Eagle handy, take a look now, and fix the exact chopping spot in your mind (it's 25 to 30 inches aft of Fire Access Door 99L and just above the aft tip of the

LAU-106A guided missile launcher — the close-up photo shows it best). Then make a close check of where the finger tabs and the UC actually are with respect to where you'd have to feel for them — maybe in the dark and surely in a hurry.

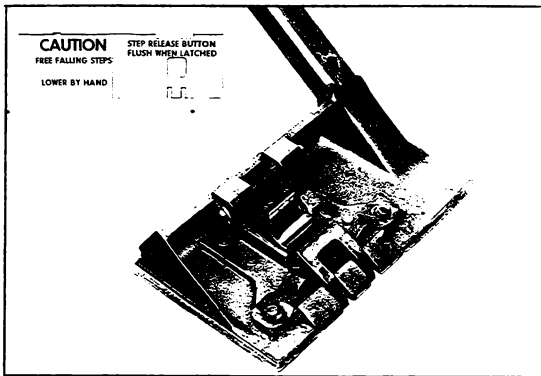
Correct step installation. Inset photo shows release button flush with moldline for locked condition. Larger photo is internal view showing staked hinge pin, release button spring sandwiched between button and step housing, and button forced back against stop indicating an unlocked condition. Compare with lower photo which shows all the problems mentioned in article.

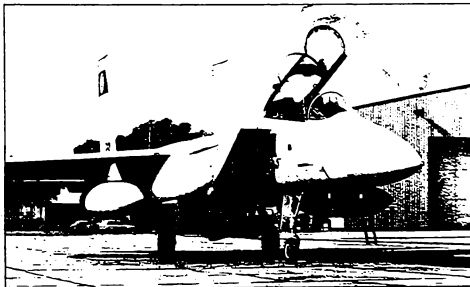
Two views of "DRF" prototype airplane. USAF 71-291 has been flying dual role evaluations for over two years.

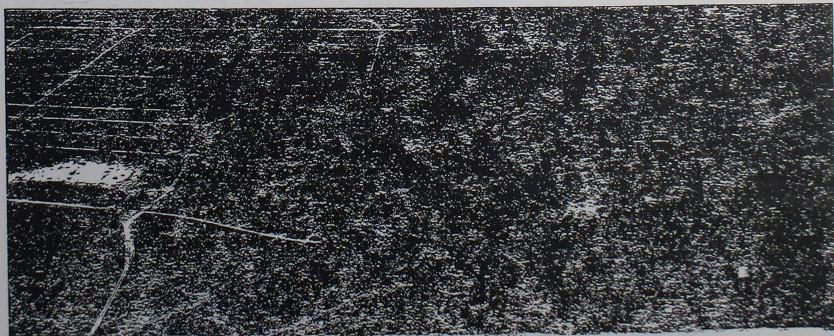
High resolution radar image (right) of armored column and tank array (left) shows scene presented to F-15 DNF crew from range of 41.51 nautical miles and altitude of 273 feet. Resulting "grazing angle" is 0.3 degree.

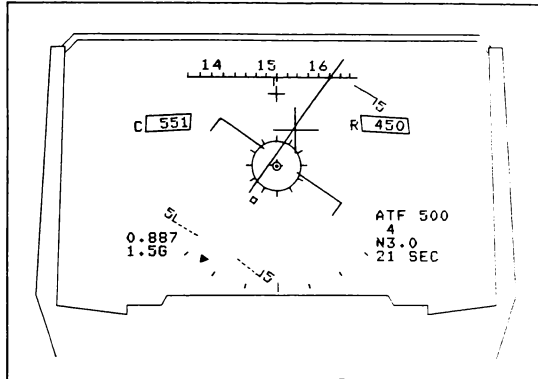
Figure 1 - Wide field-of-view HUD with improved graphics

The new HUD will be "holographic," which gives it the capability of displaying infrared video. Basics for the flight instruments (airspeed, altitude, and attitude) are presented in an easy-to-read and interpret format (Figure 1). Airspeed and altitude are large alpha-numerics which allow both to be read quickly to one knot and ten feet respectively. The pitch attitude reference lines are tilted toward the horizon, with the magnitude of the tilt angle one-half the pitch attitude. These changes qualify the HUD as the primary flight instrument. If the HUD fails, the display can be called up on any of the CRTs; and for you old diehards, an electronic ADI can also be displayed on any CRT. Basic HUD symbology for A/A and A/G weapons

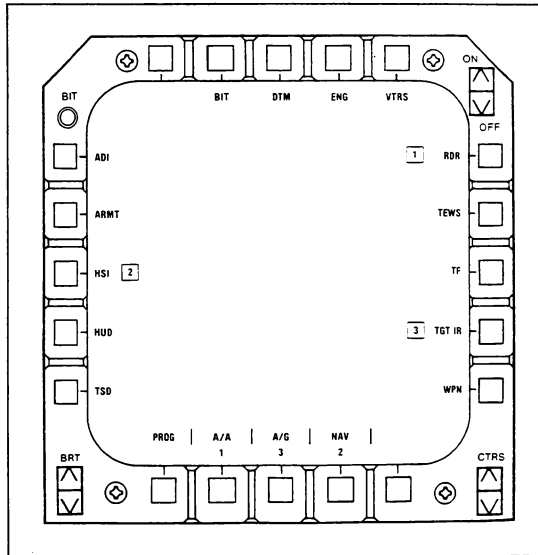
Figure 2 - Menu display showing subsystem options

The front seat will have two six-inch monochromatic (green) and one five-inch color CRTs; the back seat two six-inch monochromatic and two five-inch color. CRTs are interchangeable front and back. (Incidentally, the question often comes up at program briefings as to "how big and how many displays does the aircrew need?" My answer is that you need as large a display as can be arranged within the physical constraints!) The DRF CRTs add a dynamic dimension to the display of aircrew information in that all displays now are free of mechanical devices and can be programmed for direct reading, easy-to-interpret sources of information. Figure 2 presents a menu display that shows all the options which can be called up on any of the CRTs in either cockpit.

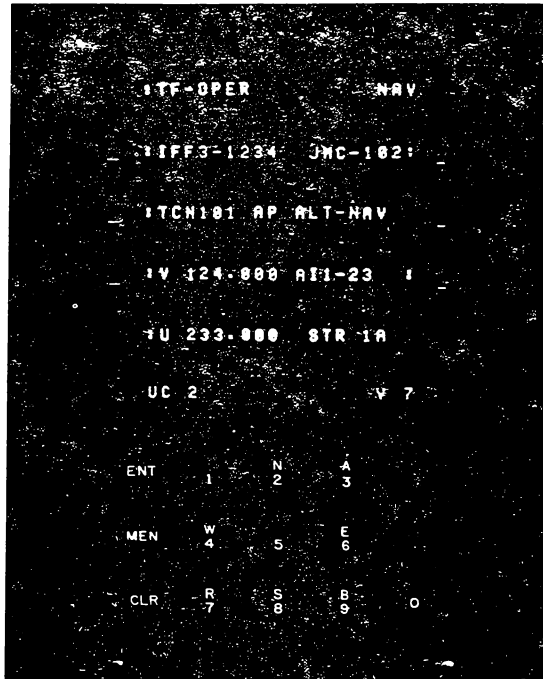
Figure 3 — UFC - advanced digital interface with avionics subsystems

A question that comes to everybody's mind is, "what if the UFC fails?" Well, there are two UFC's, and either controls all systems and each is driven by its own processor with paths to the other UFC. This arrangement provides a back-up to a UFC or processor failure.

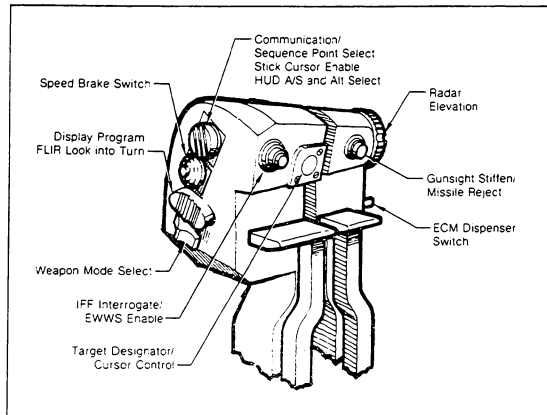
Figure 4 — Front seat throttle

Before discussing the new throttle and stick grips, let me reassure the fighter jocks that all the air superiority functions are being retained, including one-man operability. With the master arm switch in arm, the gun is still hot through the trigger. The weapon select switch on the throttle has not been changed. Switch aft to guns puts the radar into the A/A mode and the CRT displays change automatically. Subsequent movement to either missile position prepares the fire control for the appropriate shot.

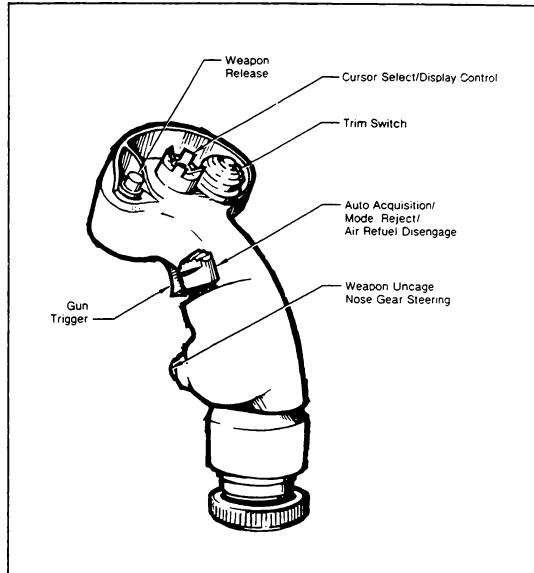
Figure 5 - Front seat stick grip

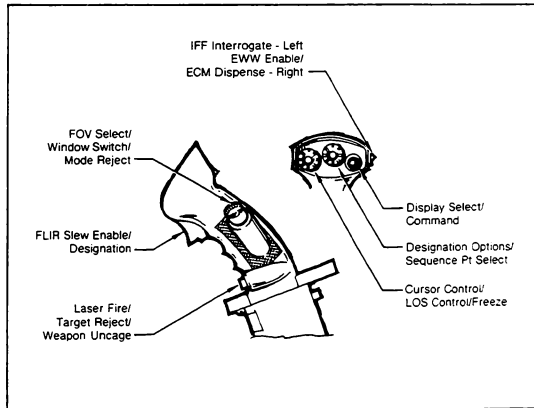
Figure 6 - Back seat hand controllers

The back seat hand controllers (Figure 6) are mirror images of each other. The left hand controller is tied to the left two CRTs; and obviously, the right controller works with the right two CRTs.

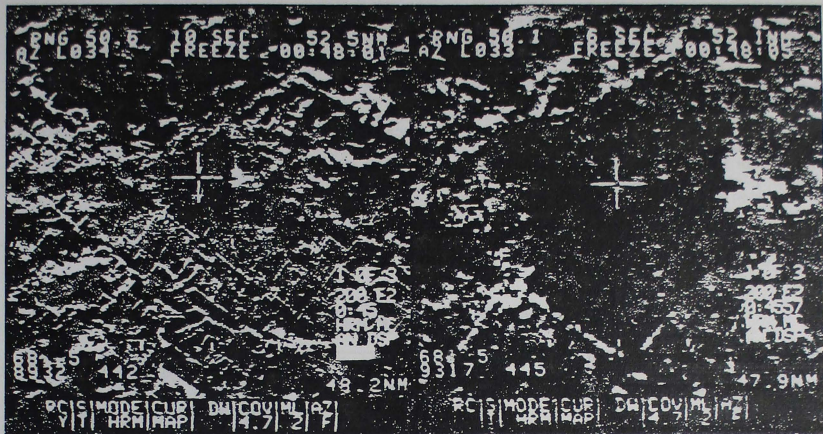
Figure 2 - "Frozen" high resolution map of Rolla, Missouri airport

Figure 3 - 3X magnification of frozen map

There were some other interesting capabilities that we experimented briefly with during the later stages of the program. For example, we flew a couple of flights with the capability of zooming in with a 3X magnification on any point of interest on a frozen map. Figure 2 shows a frozen "mother" map of the Rolla (Missouri) National airport area. Figure 3 shows a zoom on a point of interest on that map. The magnification shows some detail not obvious on the mother map. The frozen mother map can be recalled after the zoom and another point of interest selected for a second zoom. This feature looks like it would have some potential for medium resolution maps and could be included in the DRF.

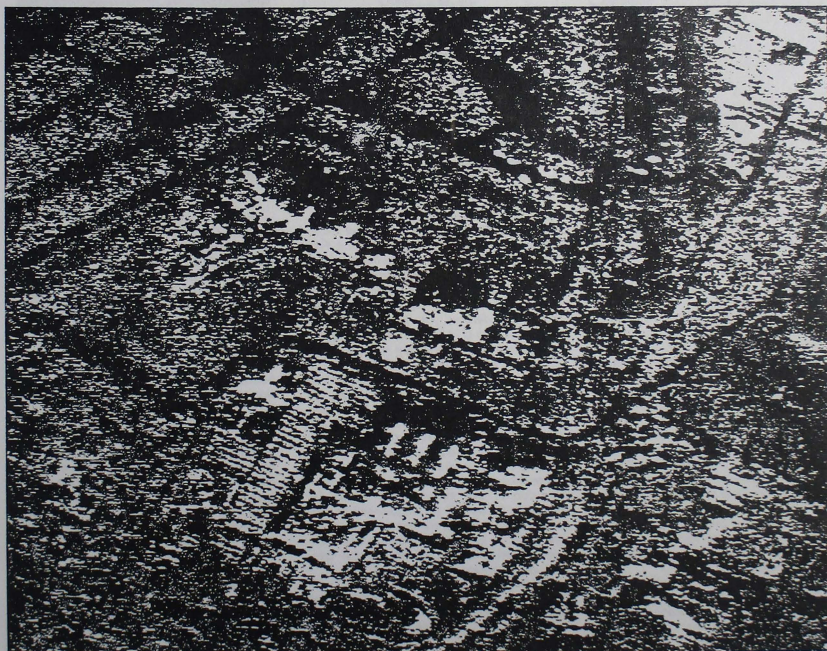
Figure 4 - Down-linked map of Lambert/St. Louis International Airport

Figure 4 shows a down-linked map of a portion of Lambert St. Louis Airport. This map was viewed by people in the ground station seconds after it was seen by the aircrew. This map was also stored in an onboard bubble memory for retrieval after landing. A bit-by-bit comparison of the two maps showed them to be identical. Once map data is stored onboard or is down linked, all

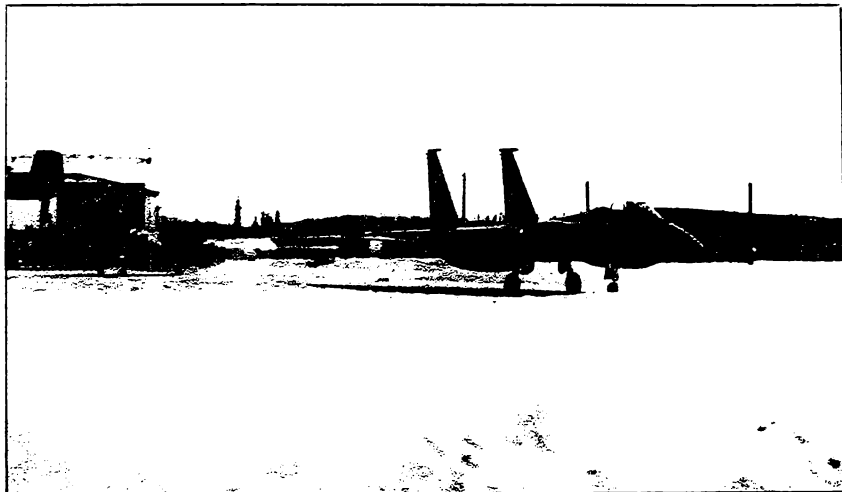
"NOBODY SAID IT WAS GOING TO BE EASY!" Photo above was taken at Elson AFB, Alaska, during F-15 Climatic Test Program conducted in 1974/75. Extreme temperature conditions — both high and low — must be expected during worldwide operations of the Eagle, and environmental impact upon both airplane and people can be severe. However, these test programs showed that the F-15 can "take it" if you can, which means that such problems as frosted windshields and icy surfaces (not to mention sand, dirt, heat, and moisture) must be met and overcome to keep the force operational and safe.
